Photonic Band Gap Accelerating Structures Progress Report

2Q FY19

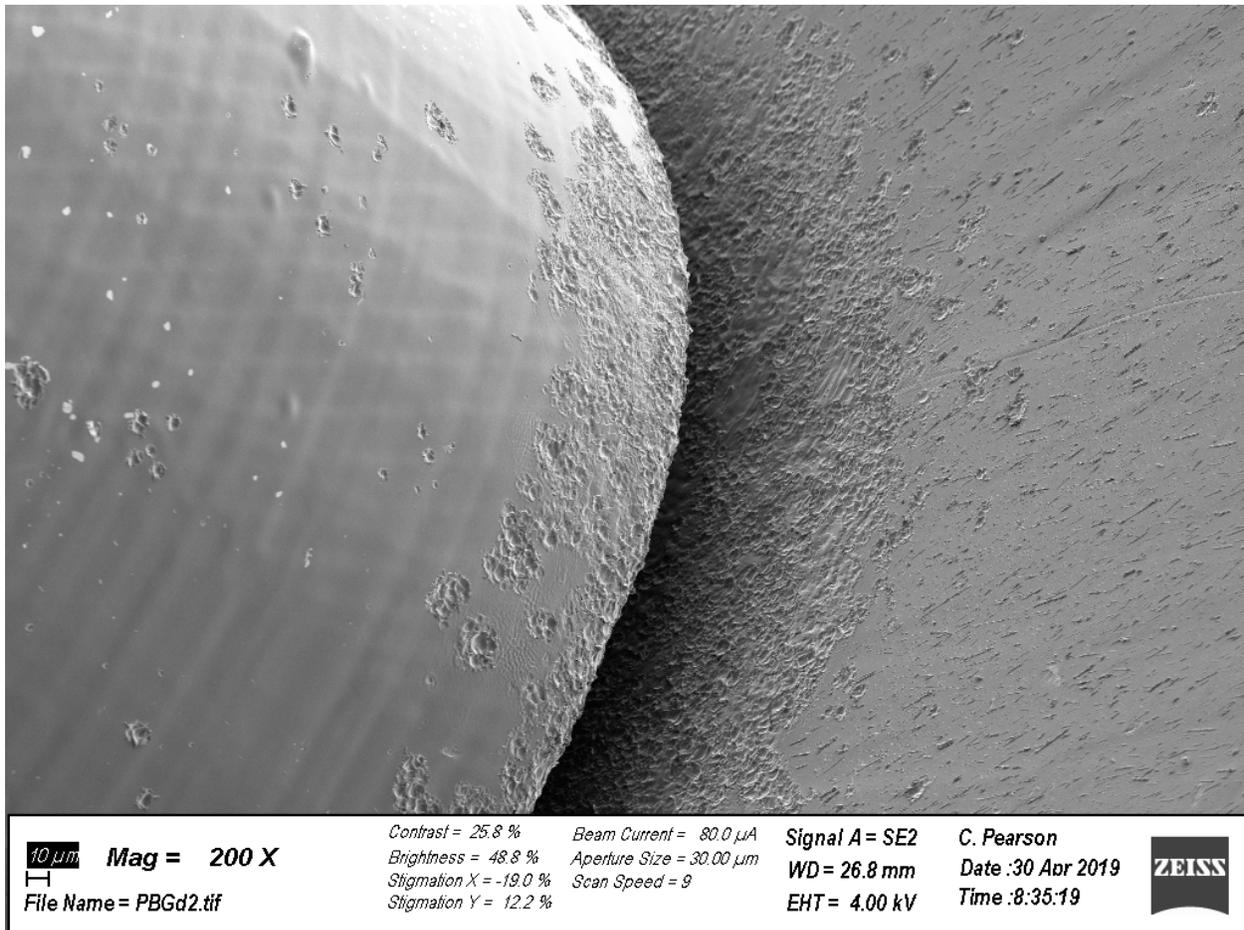
The high gradient testing of the PBG cell with elliptical rods at SLAC was conducted and failed. The structure was cut apart and examined with a scanning electron microscope (SEM). It was discovered that the failure was due to one of the PBG rod not brazed to the wall of the resonator during the brazing operation at SLAC. The photograph below shows a 10 micron gap between the PBG rod and the wall of the resonator and the traces of the multiple breakdowns surrounding the defect.
