**Subject: Submittal of the Investigation Work Plan and the Historical Investigation Report for Upper Cañada del Buey Aggregate Area**

LA-UR-08-3864  
June 2008  
EP2008-0287

# Investigation Work Plan for Upper Cañada del Buey Aggregate Area

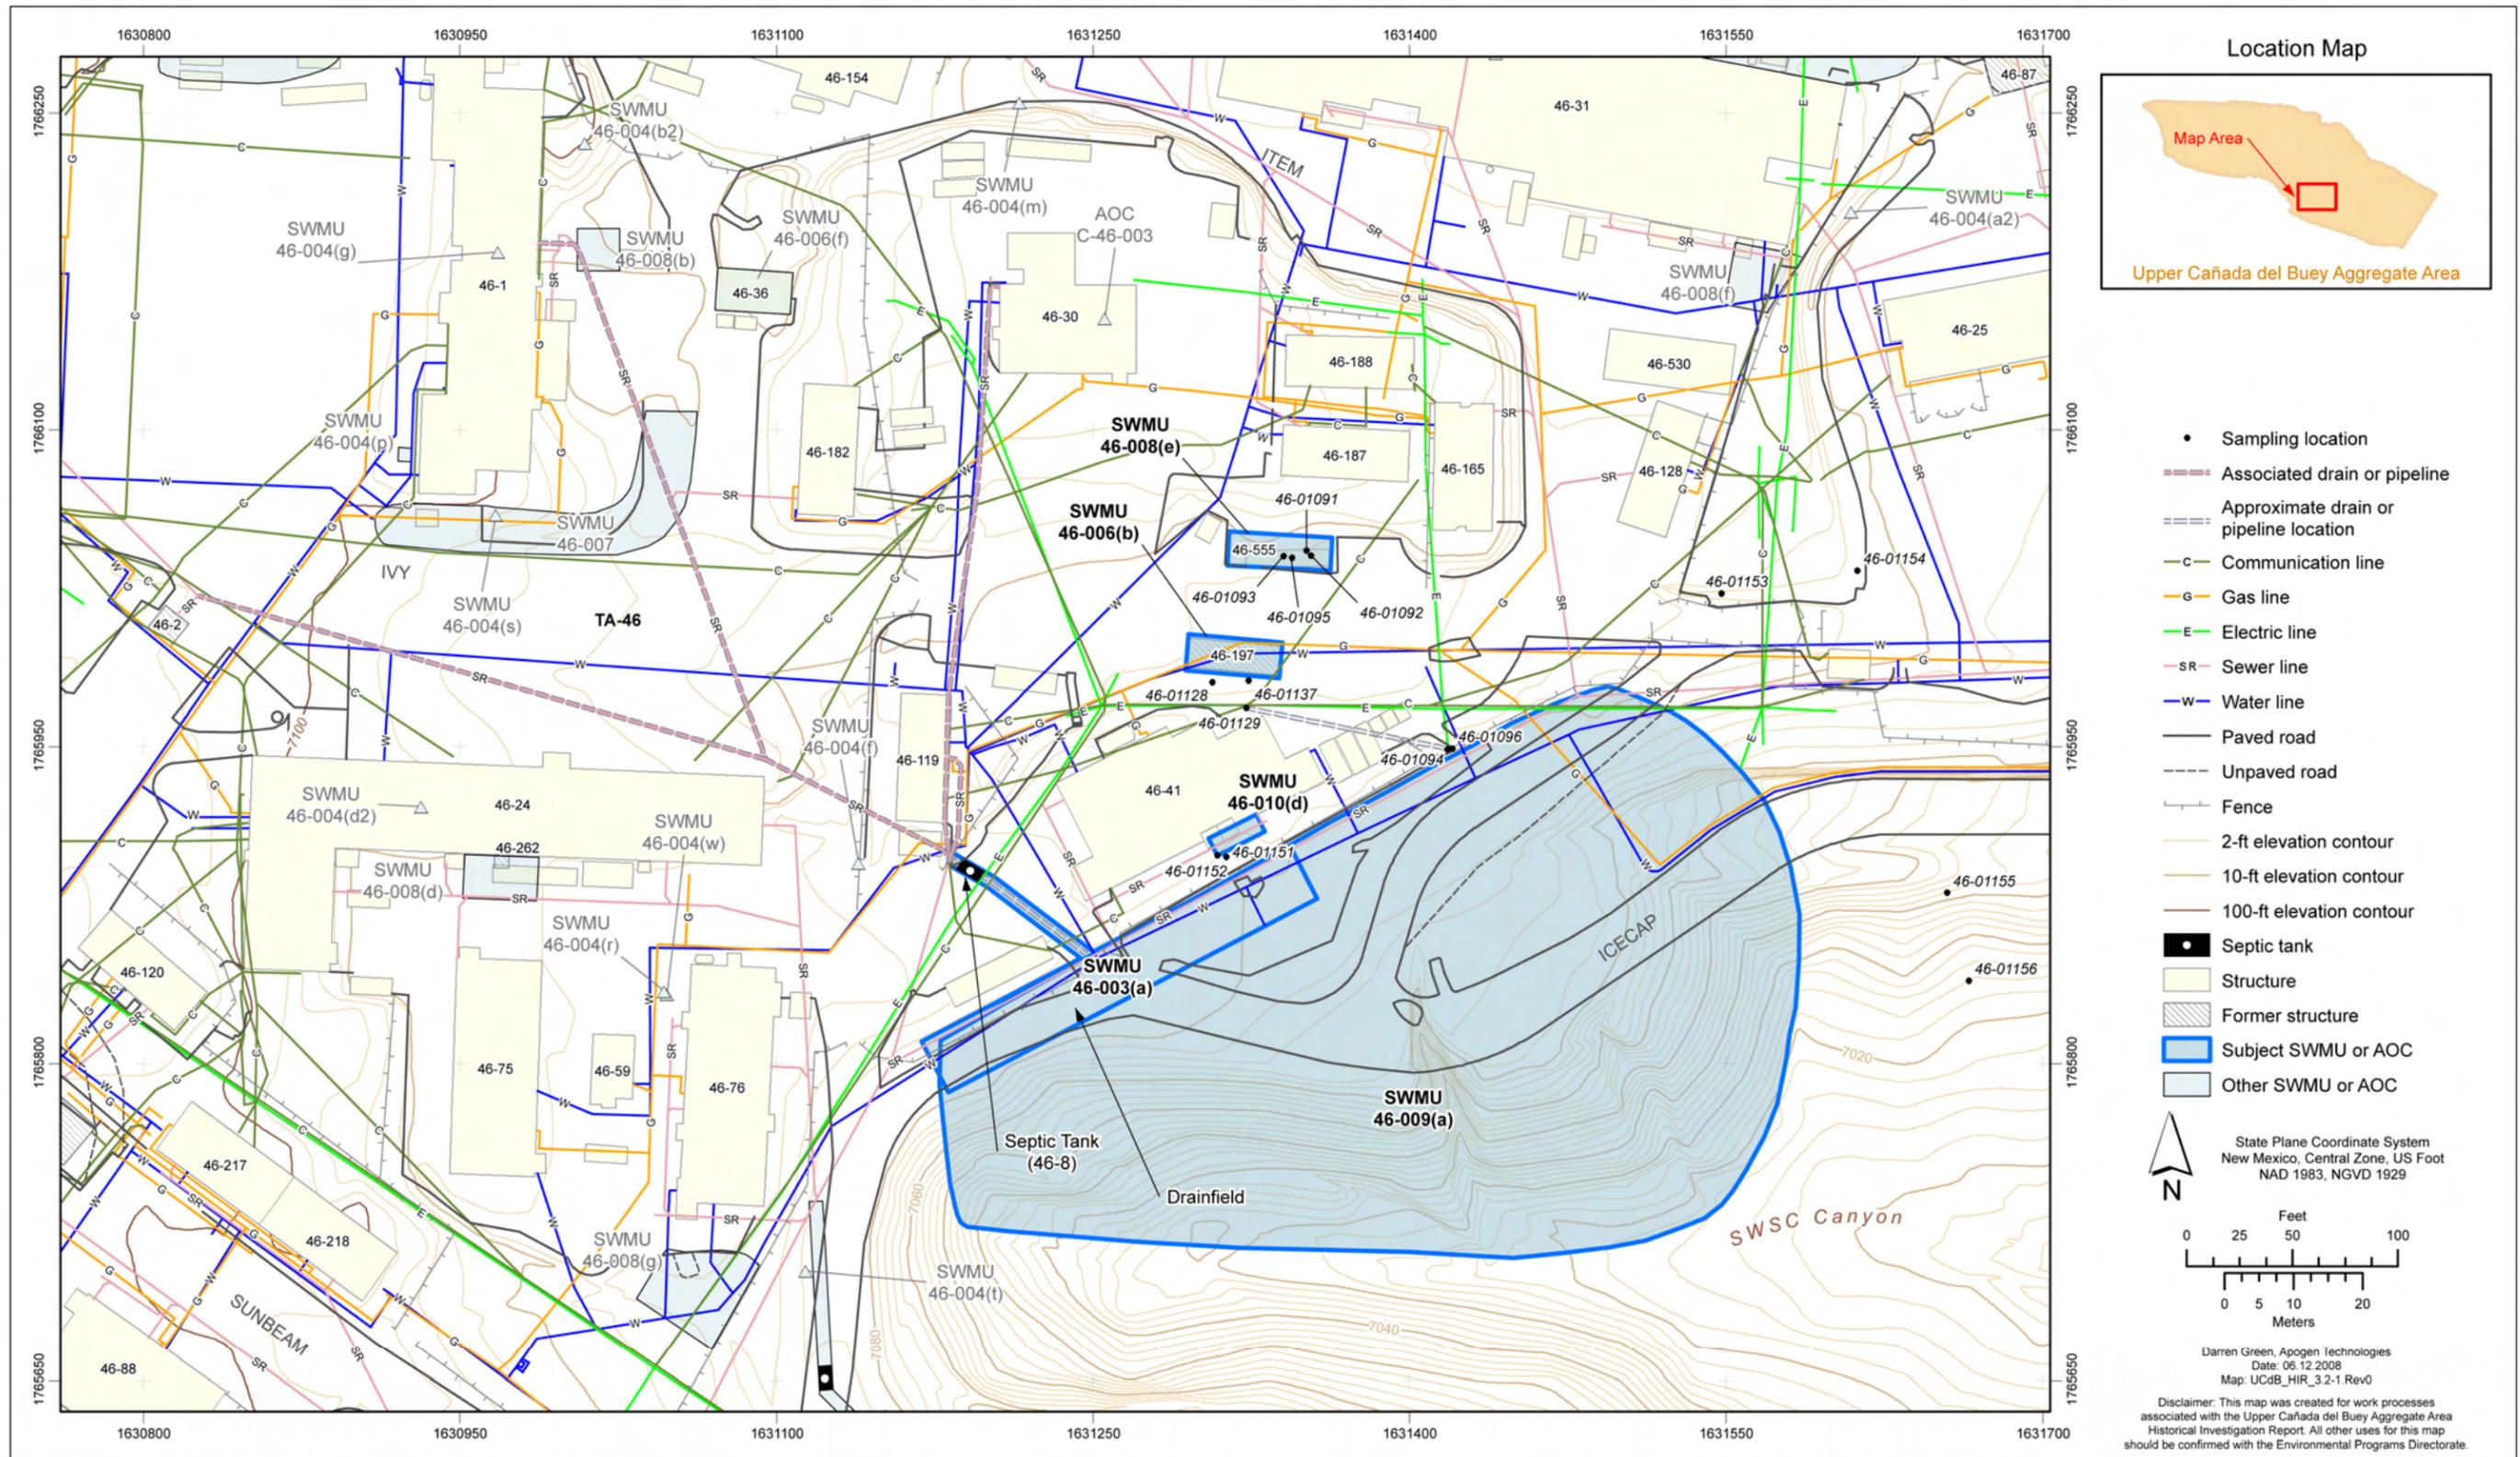
Figure 3.2-1 Site features for SWMUs 46-003(a), 46-006(b), 46-008(e), 46-009(a), and 46-010(d)

SWMU 46-006(b) is the site of a former storage shed (structure 46-197) located approximately 40 ft north of the Laser Isotope Support Facility (building 46-41) (Figure 3.2-1). The shed was approximately 40 ft long × 8 ft wide, constructed of plywood on three sides (the north side was open) with a sheet-metal roof. The shed was used for short-term storage of oil drums, vacuum pumps, optical tables, other laboratory equipment, and electrical equipment with PCB-containing oil. The shed was installed sometime before 1977 and removed in 1990 (LANL 1993, 020952, p. 5-77). The site of the shed is paved with asphalt and slopes toward a storm drain to the southeast. During a 1986 site visit of the area, oil was observed leaking from under the back of the shed. In addition, an oil spill was observed east of the shed, and discolored soil was observed at the storm drain outfall (LANL 1993, 020952, p. 5-77).

SWMU 46-008(e) is an unpaved storage area located south of an office transportable (building 46-187) (Figure 3.2-1). The 20-ft x 35-ft area has been used for storage since the 1950s. A storage shed (structure 46-79) formerly occupied the site but was removed sometime before 1988. Drums of waste vacuum oil were noted to be stored at the site during a 1986 site visit (LANL 1993, 020952, p. 5-81). Traces of asphalt in the soil indicate that the area formerly may have been paved. An office transportable (building 46-555) currently occupies the site. Drainage from the area flows east into a storm drainage that discharges to SWSC Canyon outside the TA-46 perimeter fence (LANL 1993, 020952, p. 5-81).

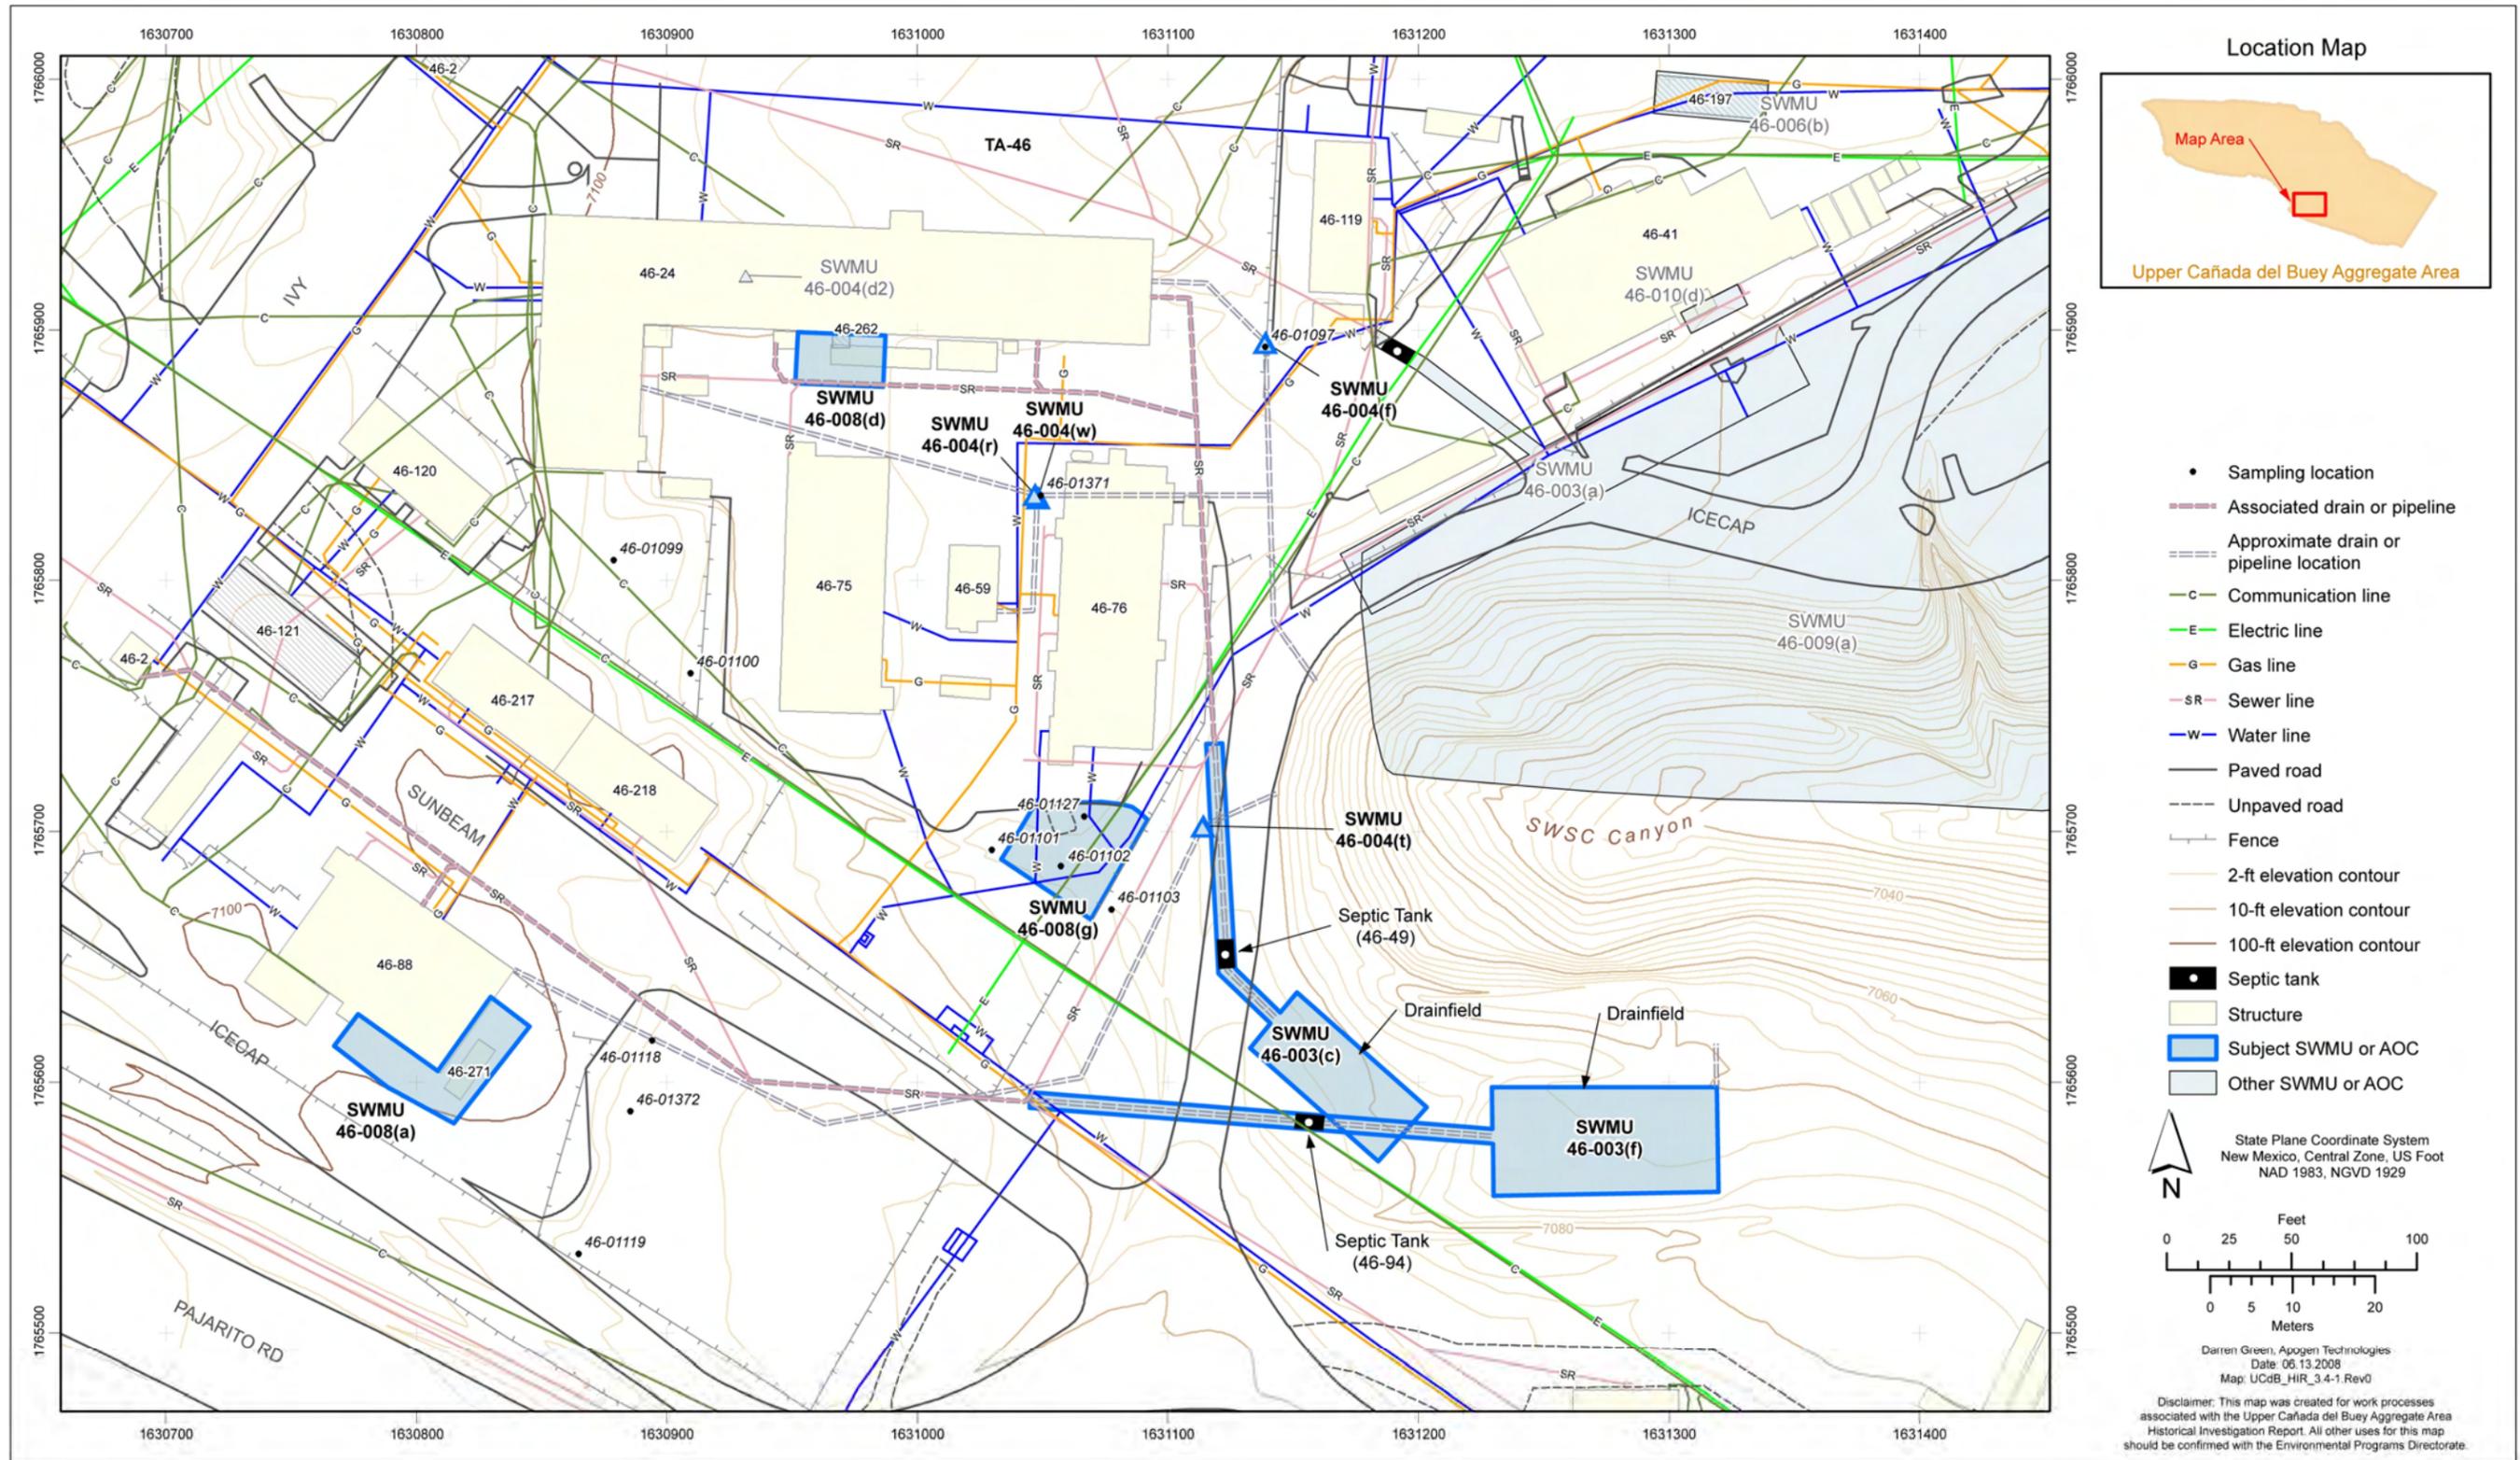
Figure 3.4-1 Site features for SWMUs 46-003(c), 46-003(f), 46-004(f), 46-004(r), 46-004(t), 46-004(w), 46-008(a), 46-008(d), and 46-008(g)

SWMU 46-008(a) is a storage area (Figure 3.4-1) located along the south and east sides of building 46-88 used to store laboratory equipment and supplies. In the late 1960s and early 1970s,

SWMU 46-008(d) is a paved storage area located on the south side of building 46-24 (Figure 3.4-1). This area stored laboratory equipment and supplies. A 1988 site visit noted two unlabeled barrels of oil on the south side of structure 46-262, a small shed on the south side of building 46-24 (LANL 1990, 007513, p. 215).

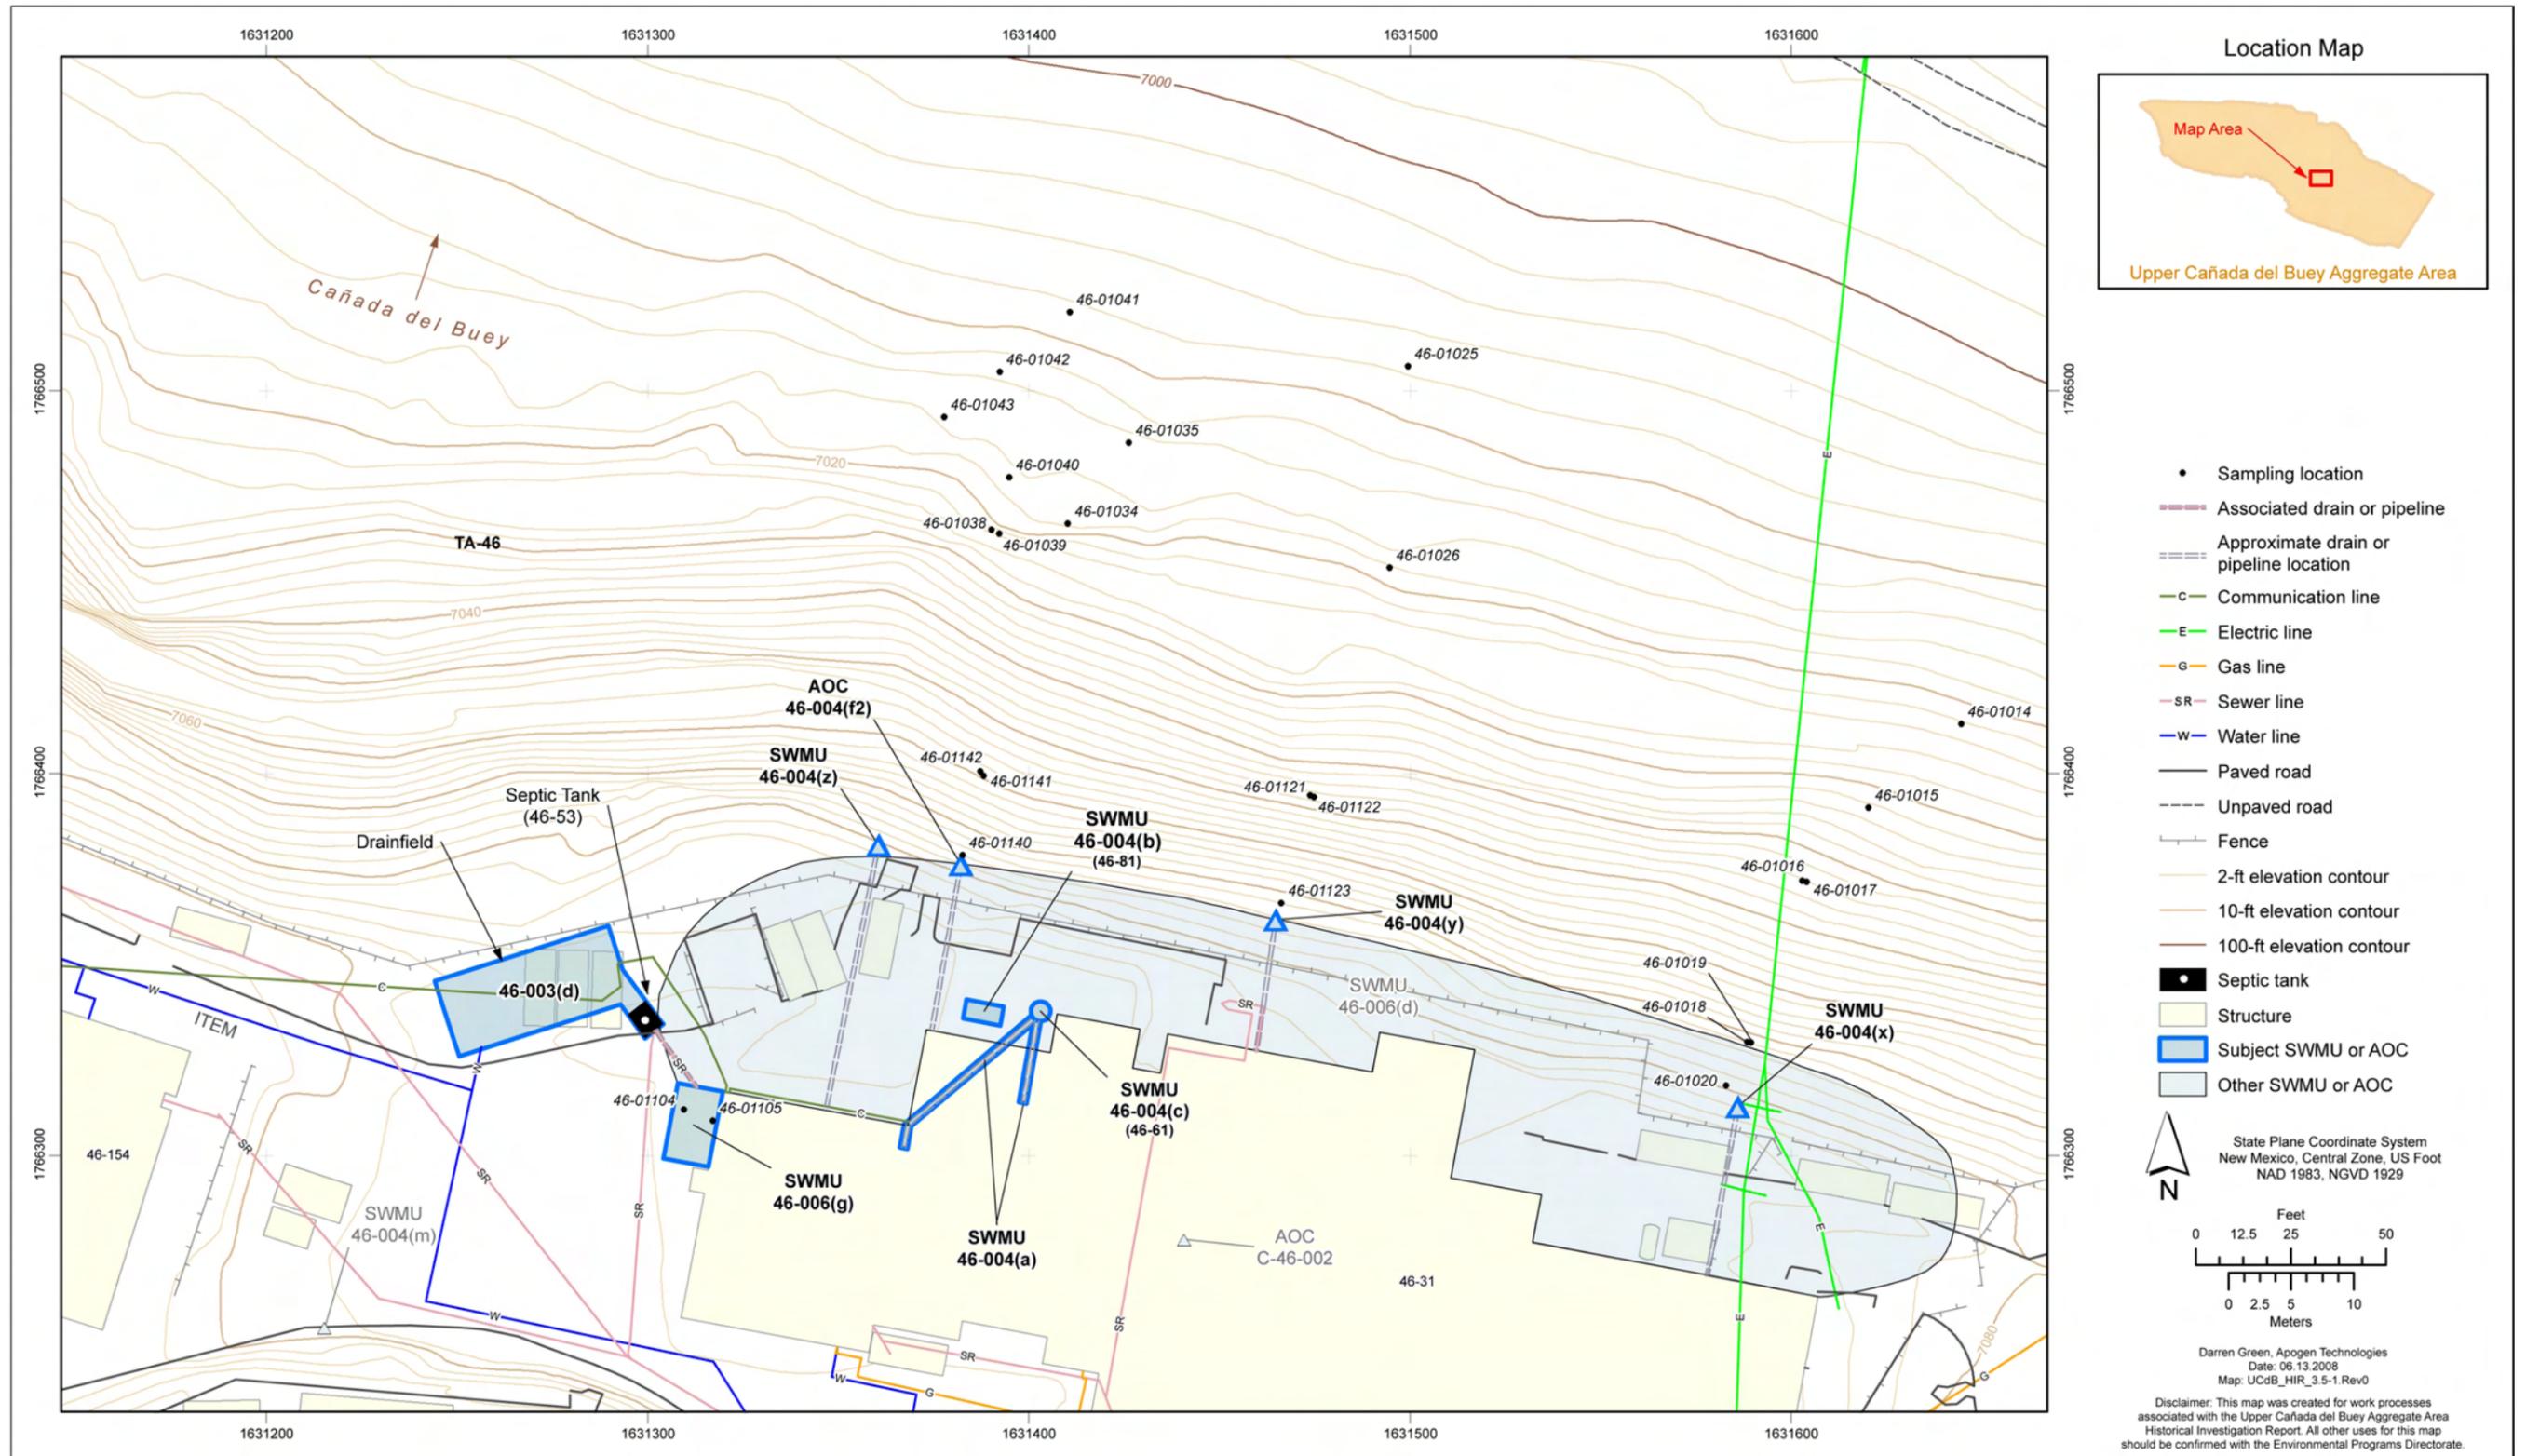
Figure 3.5-1 Site features for SWMUs 46-003(d), 46-004(a), 46-004(b), 46-004(c), 46-004(x), 46-004(y), 46-004(z), and 46-006(g) and AOC 46-004(f2)

SWMU 46-006(g) is a storage shed and surrounding area located at the west end of building 46-31 (Figure 3.5-1). The shed is of corrugated steel construction and measures 10 ft × 20 ft. From 1982 to 1984, the shed housed vacuum pumps used in experiments involving plasma vaporization of depleted uranium powder. The area around the shed is level and paved. Because the shed was not weather-tight, rain and snowmelt routinely flooded the floor. Pump oil is known to have been spilled on the floor of the shed (LANL 1996, 054929, p. 194).

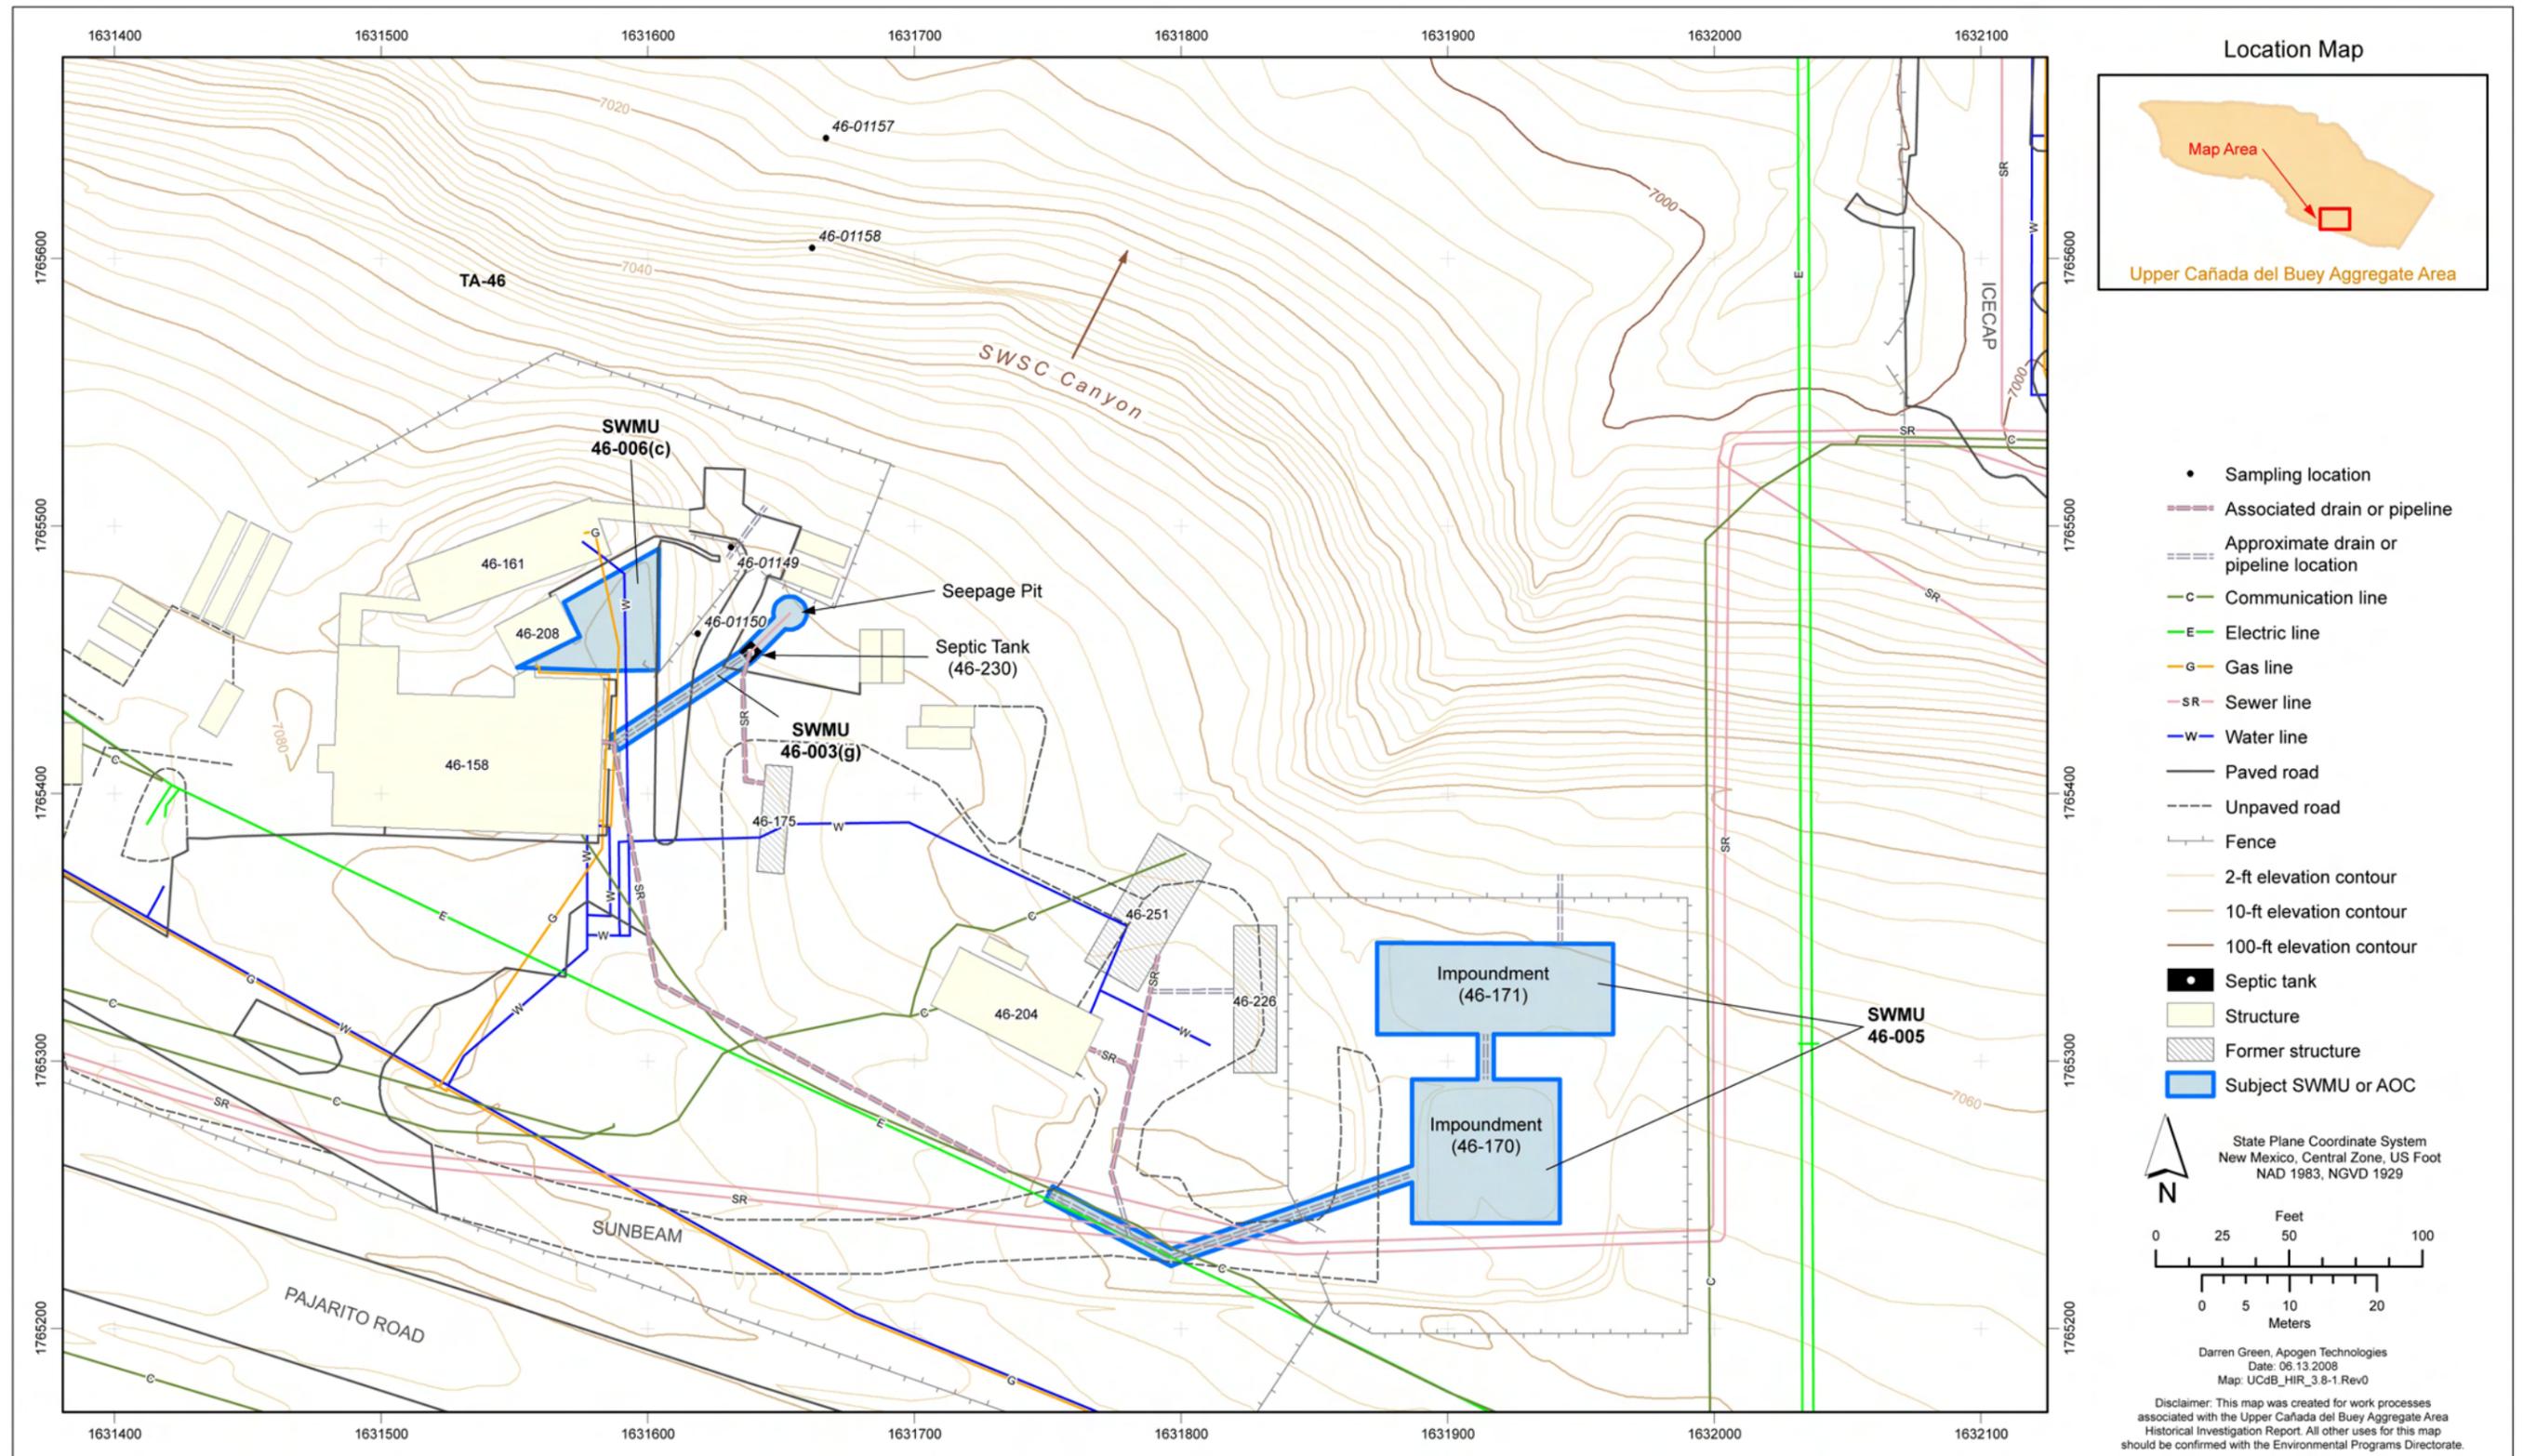
Figure 3.8-1 Site features for SWMUs 46-003(g), 46-005, and 46-006(c)

SWMU 46-006(c) is a paved 15-ft x 30-ft storage area located between the northeast corner of building 46-158 and the southeast side of building 46-208 (Figure 3.8-1). Some of the pavement is stained. The area is currently used to store laboratory equipment and supplies. Asphalt curbing directs runoff into a storm drain discharging to SWSC Canyon. During a 1986 site visit, drums were leaking and oil was noted to be draining into the storm drain. The drums were removed before 1994 (LANL 1993, 020952, pp. 5-77–5-78, 5-104).

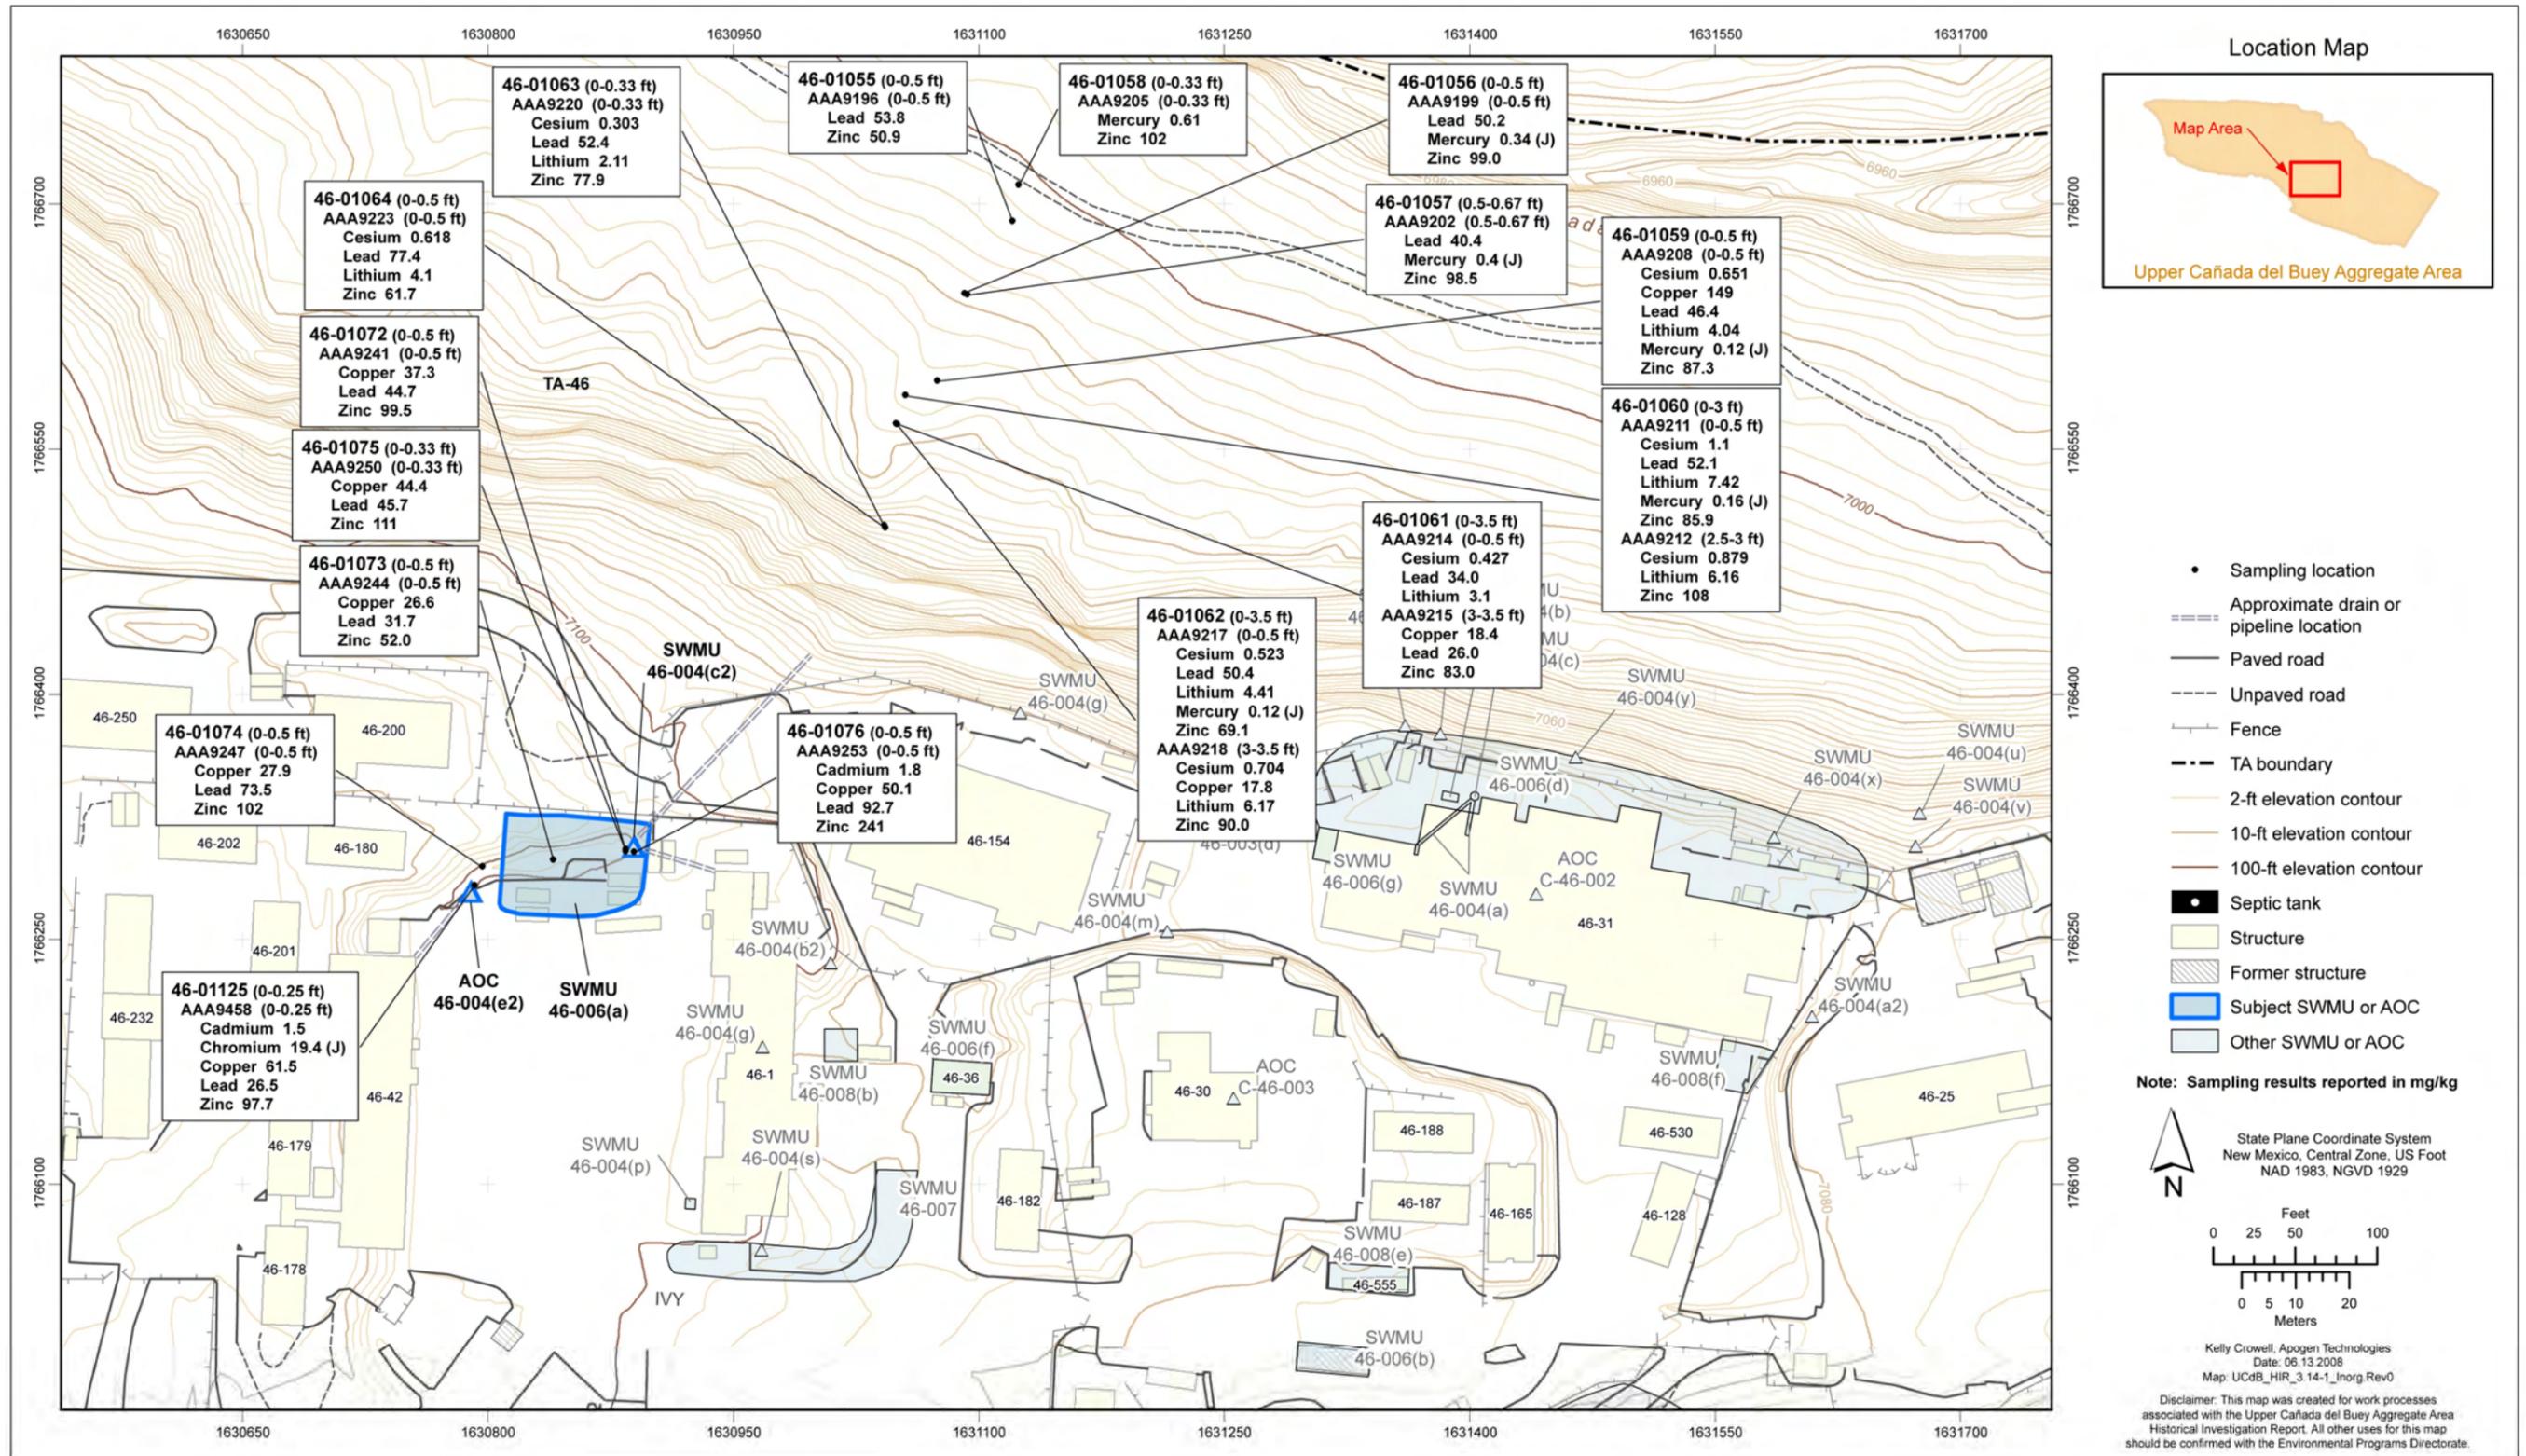
Figure 3.14-1 Inorganic chemicals detected above BVs at SWMUs 46-004(c2) and 46-006(a) and AOC 46-004(e2)

Analytical data from the 1994 Phase I RFI are presented in Tables 3.33-2 and 3.33-3. The sampling locations and results for inorganic chemicals detected above BVs and organic chemicals detected are shown in Figures 3.14-1 and 3.14-2, respectively. Copper, lead, and zinc were detected above BVs in both samples. Detection limits for cadmium and silver were above BVs in both samples. DDE(4,4'-), dieldrin, and endrin aldehyde were detected in one sample. Anthracene, benzo(a)anthracene, benzo(a)pyrene, benzo(b)fluoranthene, chrysene, DDT(4,4'-), endosulfan II, endrin, fluoranthene, methoxychlor(4,4'-), phenanthrene, and pyrene were detected in both samples. VOCs and PCBs were not detected. Radionuclides were not detected or were not detected above BVs/FVs.
