**Subject: Submittal of the Investigation Work Plan and the Historical Investigation Report for Upper Cañada del Buey Aggregate Area**

LA-UR-08-3864  
June 2008  
EP2008-0287

# Investigation Work Plan for Upper Cañada del Buey Aggregate Area

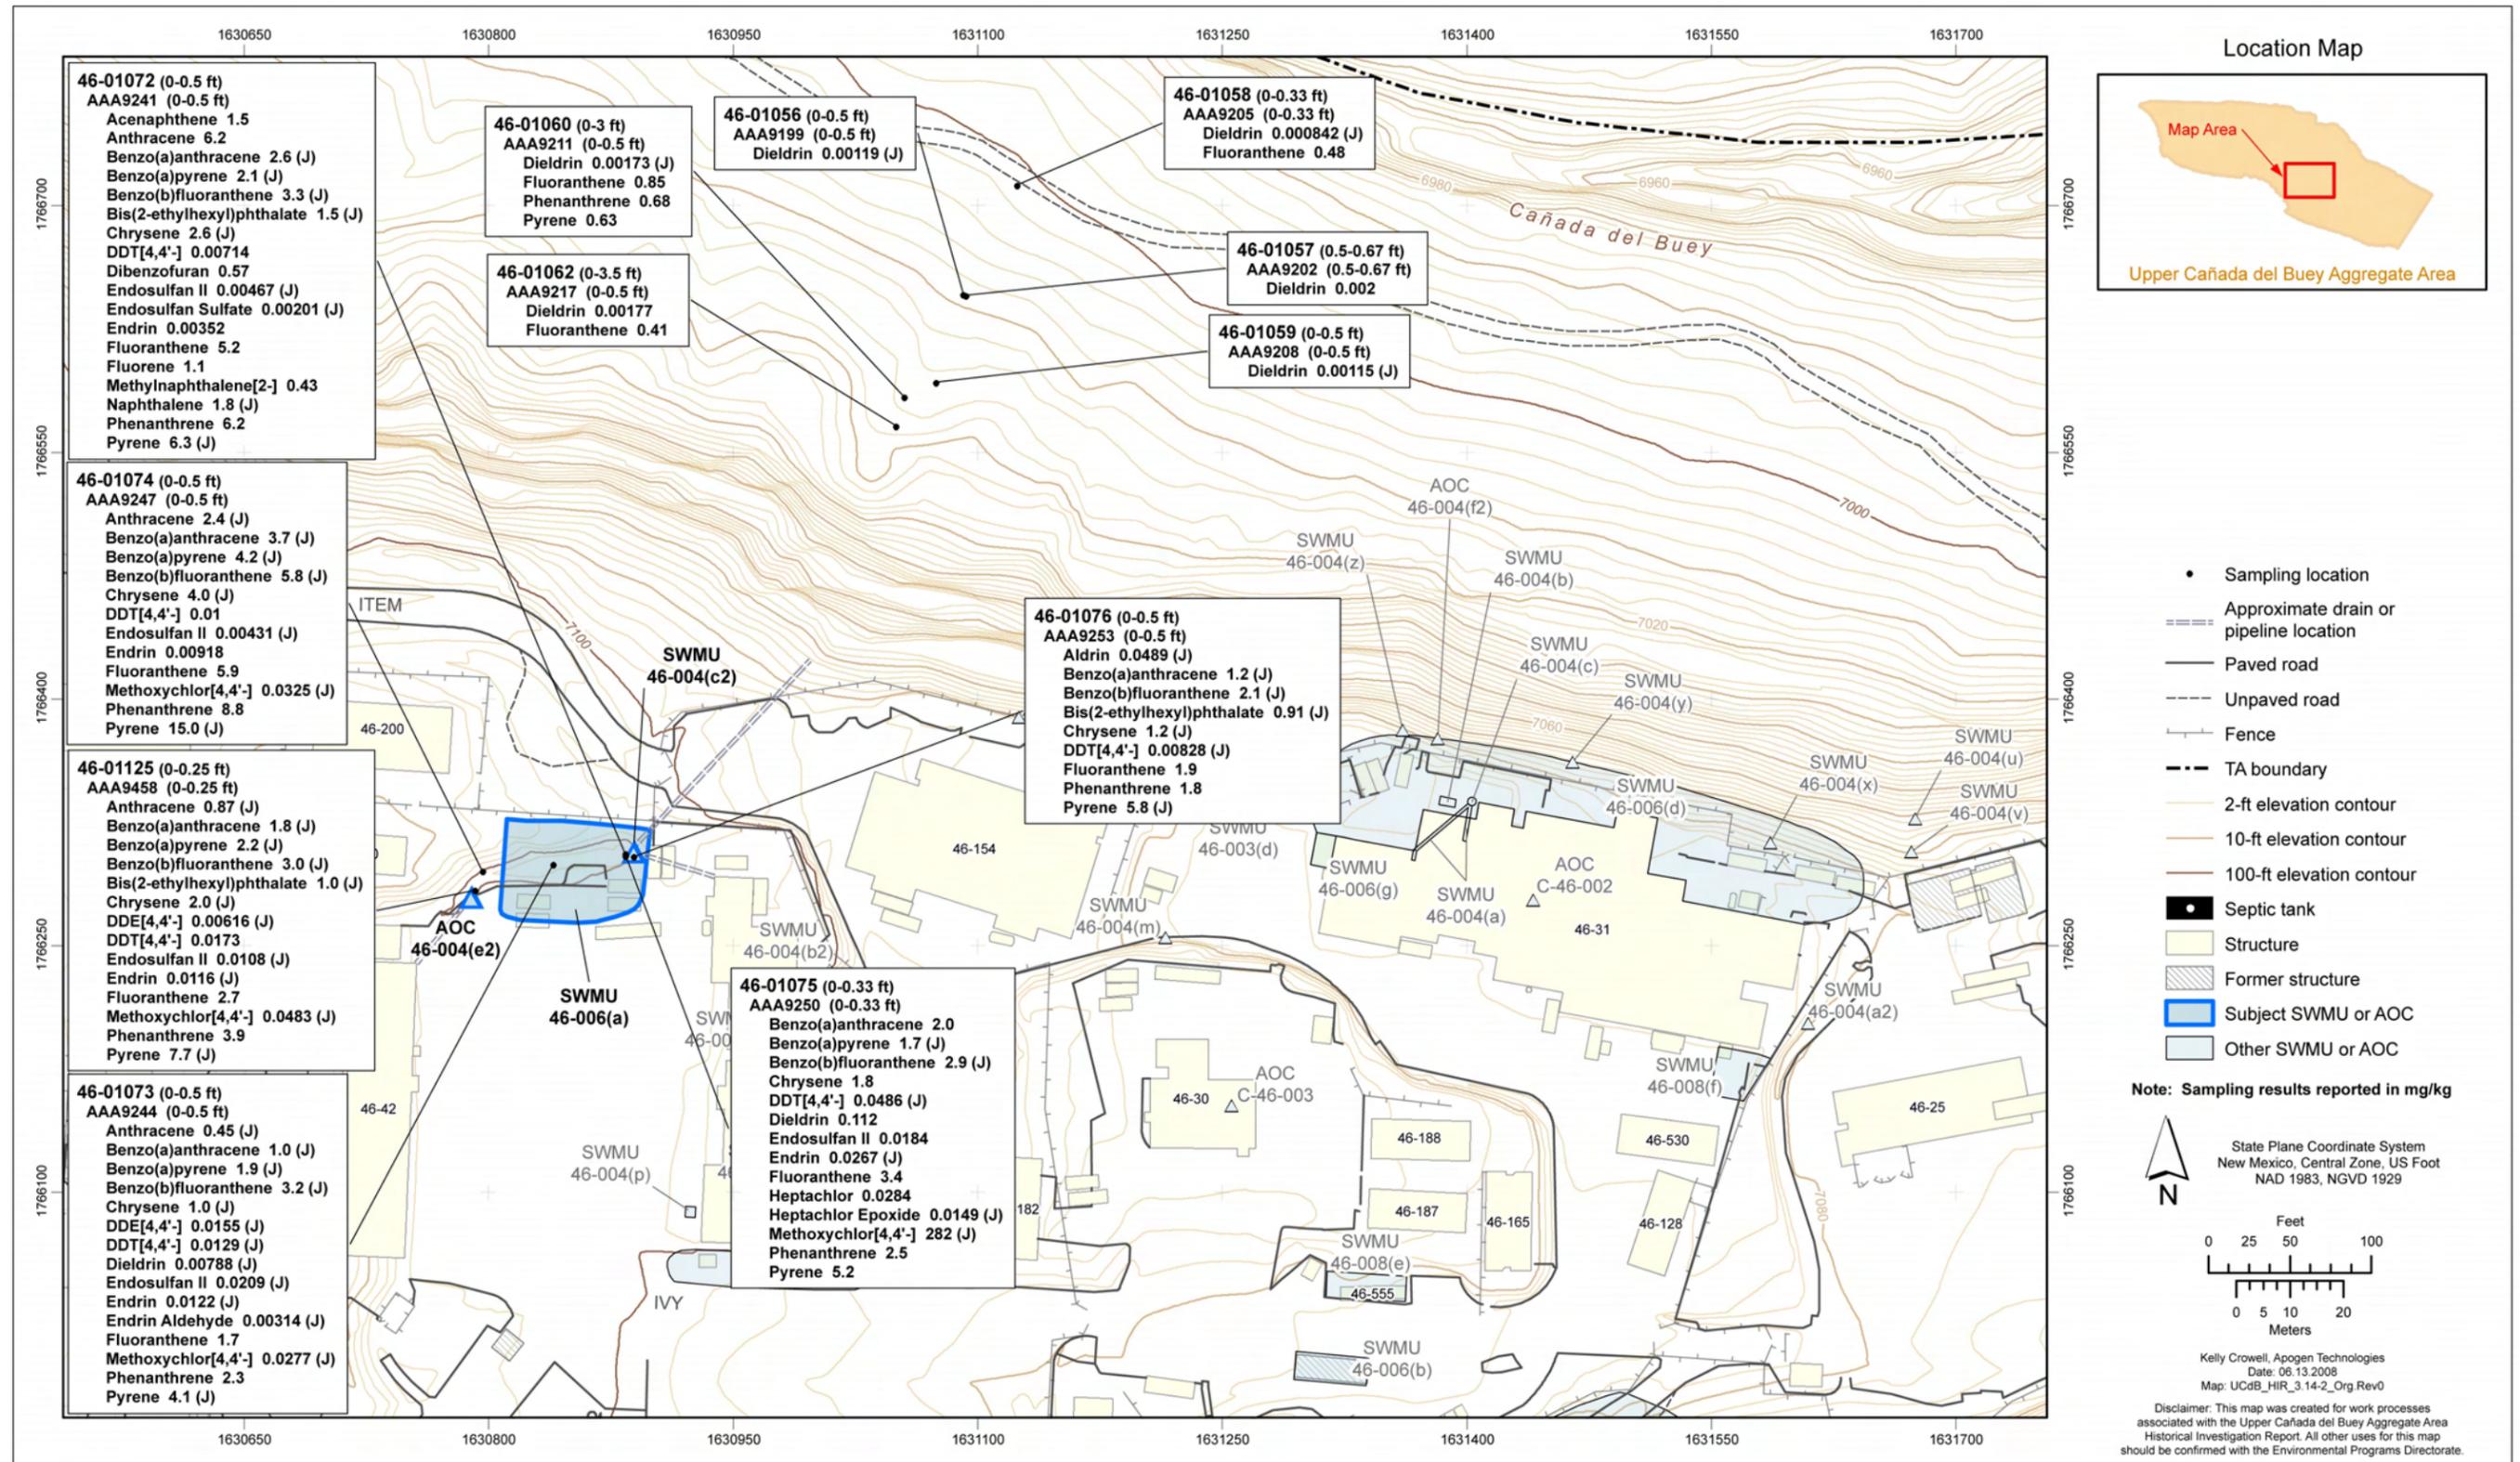
Figure 3.14-2 Organic chemicals detected at SWMUs 46-004(c2) and 46-006(a) and AOC 46-004(e2)

Analytical data from the 1994 Phase I RFI are presented in Tables 3.33-2 and 3.33-3. The sampling locations and results for inorganic chemicals detected above BVs and organic chemicals detected are shown in Figures 3.14-1 and 3.14-2, respectively. Copper, lead, and zinc were detected above BVs in both samples. Detection limits for cadmium and silver were above BVs in both samples. DDE(4,4'-), dieldrin, and endrin aldehyde were detected in one sample. Anthracene, benzo(a)anthracene, benzo(a)pyrene, benzo(b)fluoranthene, chrysene, DDT(4,4'-), endosulfan II, endrin, fluoranthene, methoxychlor(4,4'-), phenanthrene, and pyrene were detected in both samples. VOCs and PCBs were not detected. Radionuclides were not detected or were not detected above BVs/FVs.

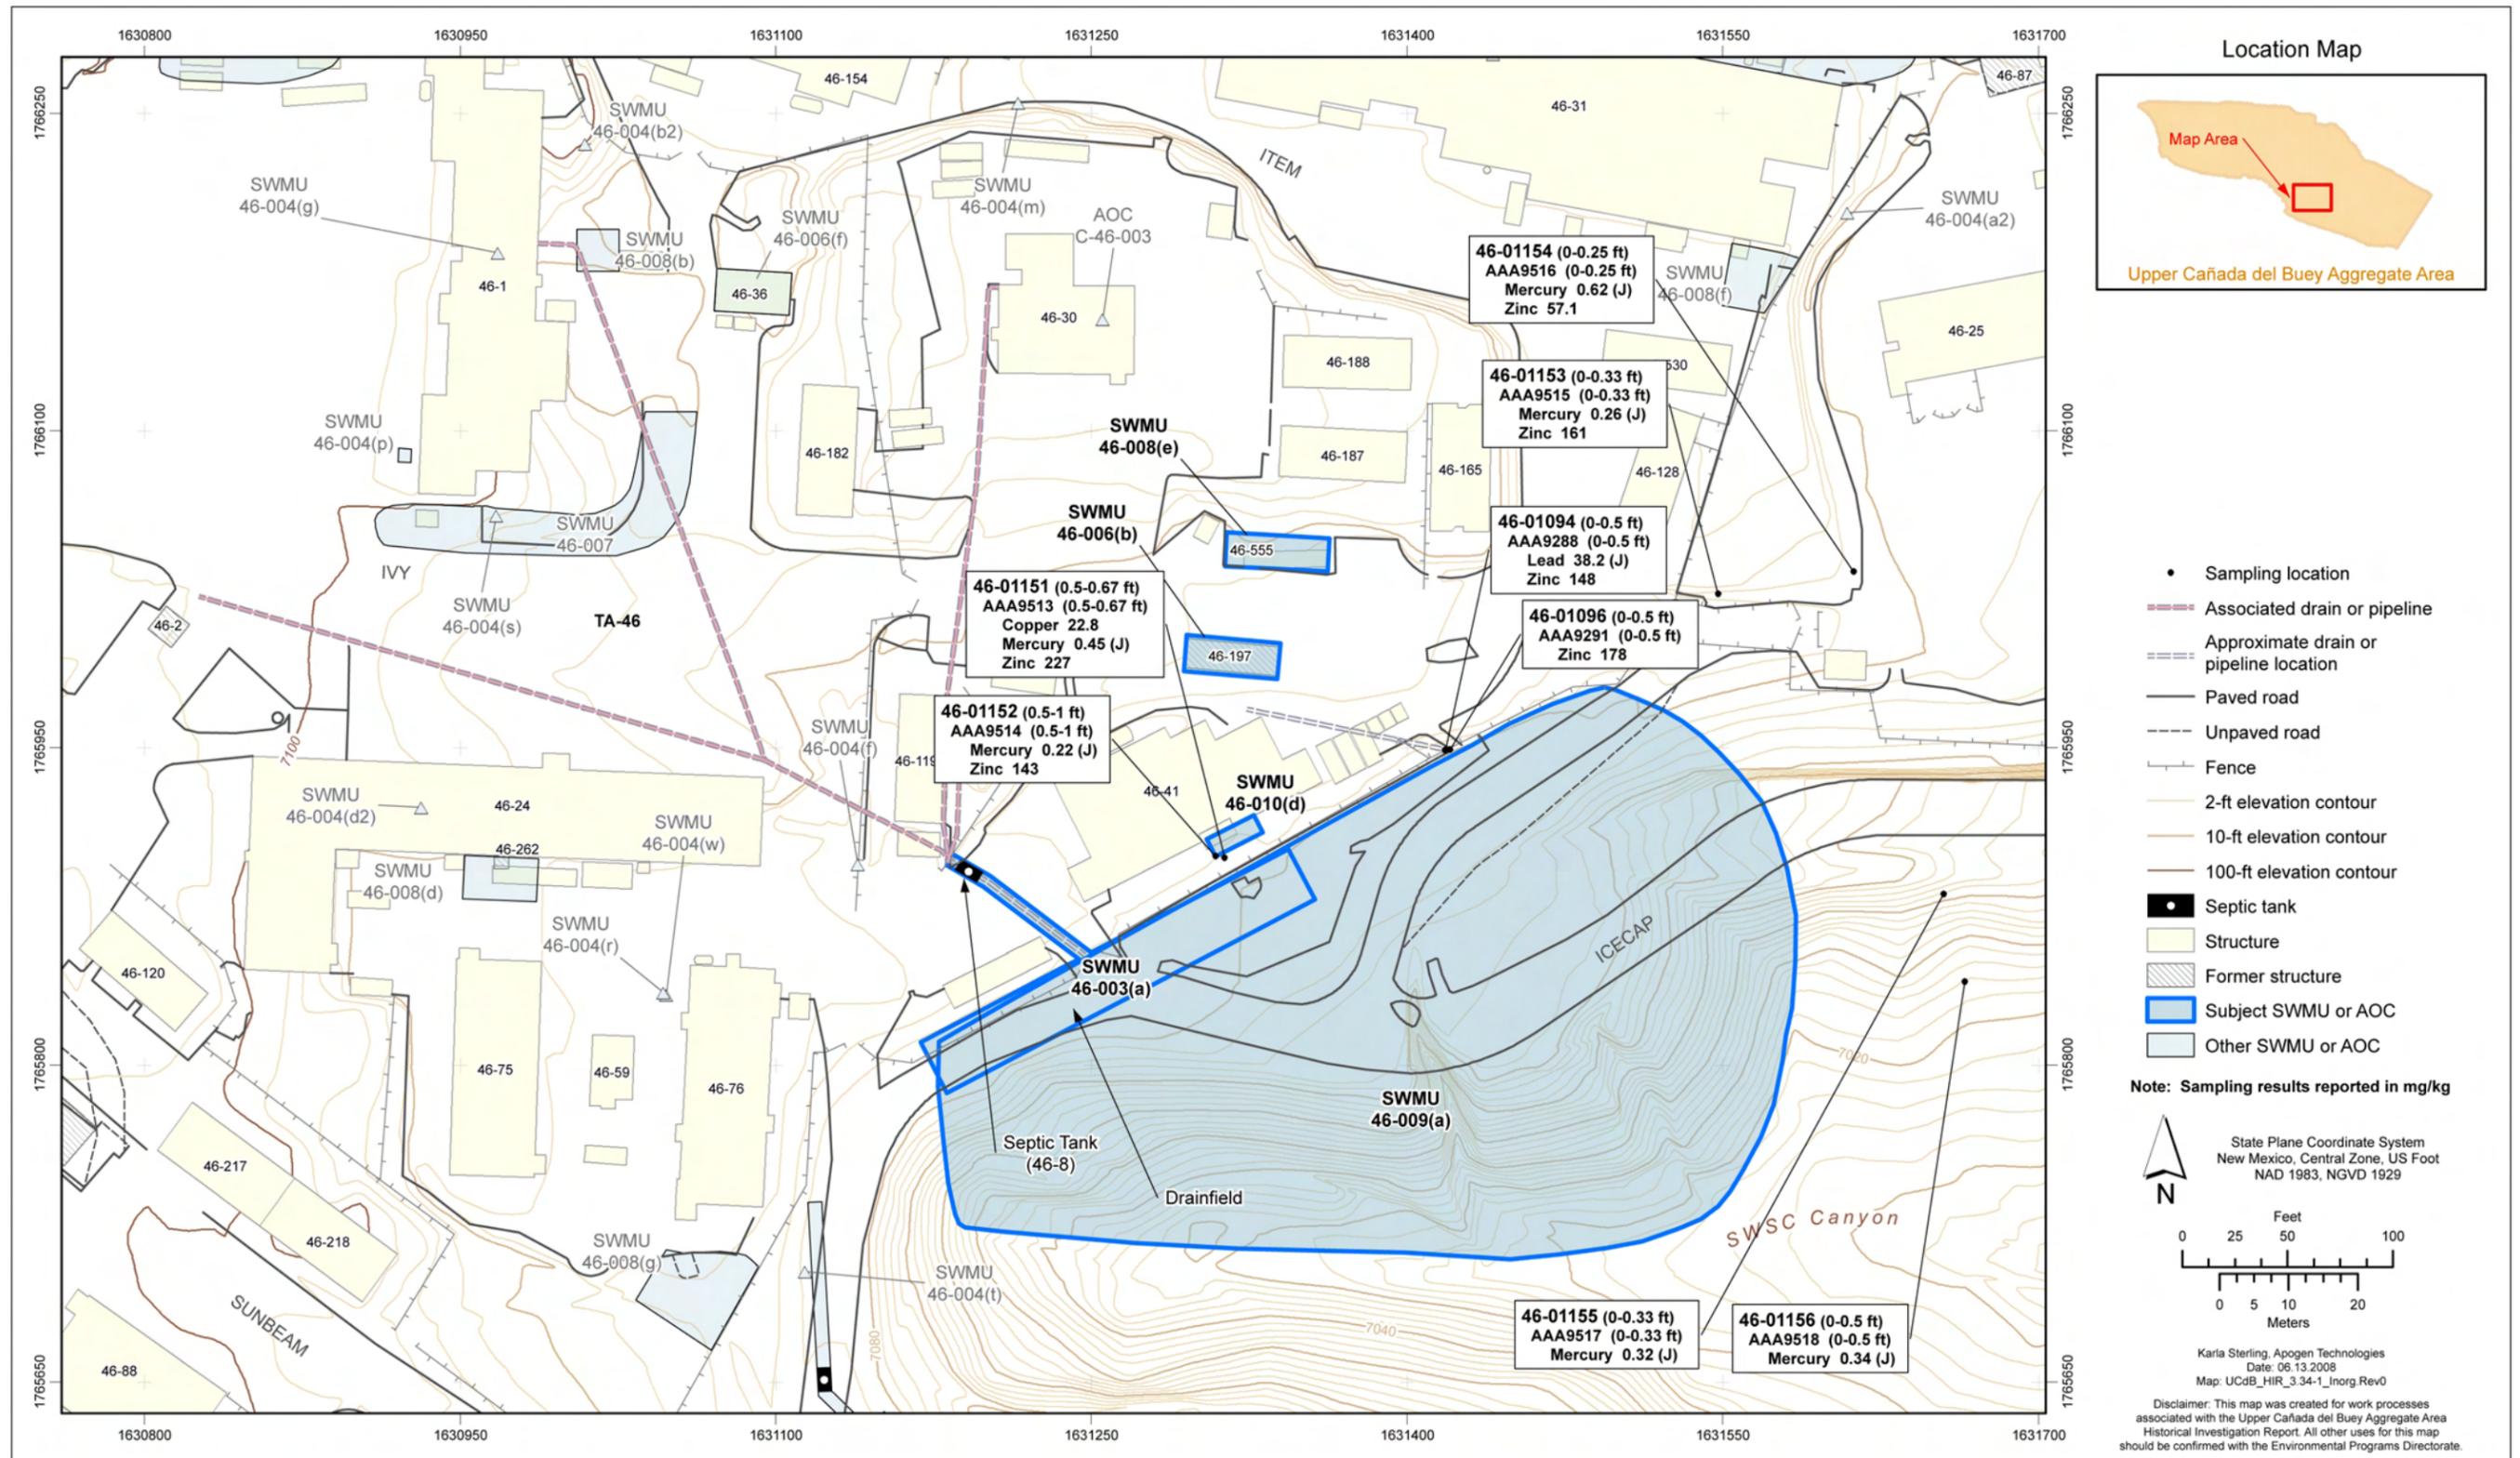
Figure 3.34-1 Inorganic chemicals detected above BVs at SWMUs 46-006(b), 46-008(e), and 46-010(d)

Analytical data are presented in Tables 3.34-2, 3.34-3, and 3.34-4. The sampling locations and results for inorganic chemicals detected above BVs, organic chemicals detected, and radionuclides detected or detected above BVs/FVs are shown in Figures 3.34-1, 3.34-2, and 3.34-3, respectively. Lead was detected above BV in one soil sample; zinc was detected above BV in two soil samples. Detection limits for cadmium and silver were above BVs in all five samples. Benzo(a)anthracene, benzo(b)fluoranthene, bis(2-ethylhexyl)phthalate, chrysene, fluoranthene, and phenanthrene were detected in one soil sample. Pyrene was detected in two soil samples. Uranium-235 was detected above BV in one soil sample. Radionuclides analyzed by gamma spectroscopy and isotopic thorium were not detected or were not detected above BVs/FVs. PCBs were not detected.

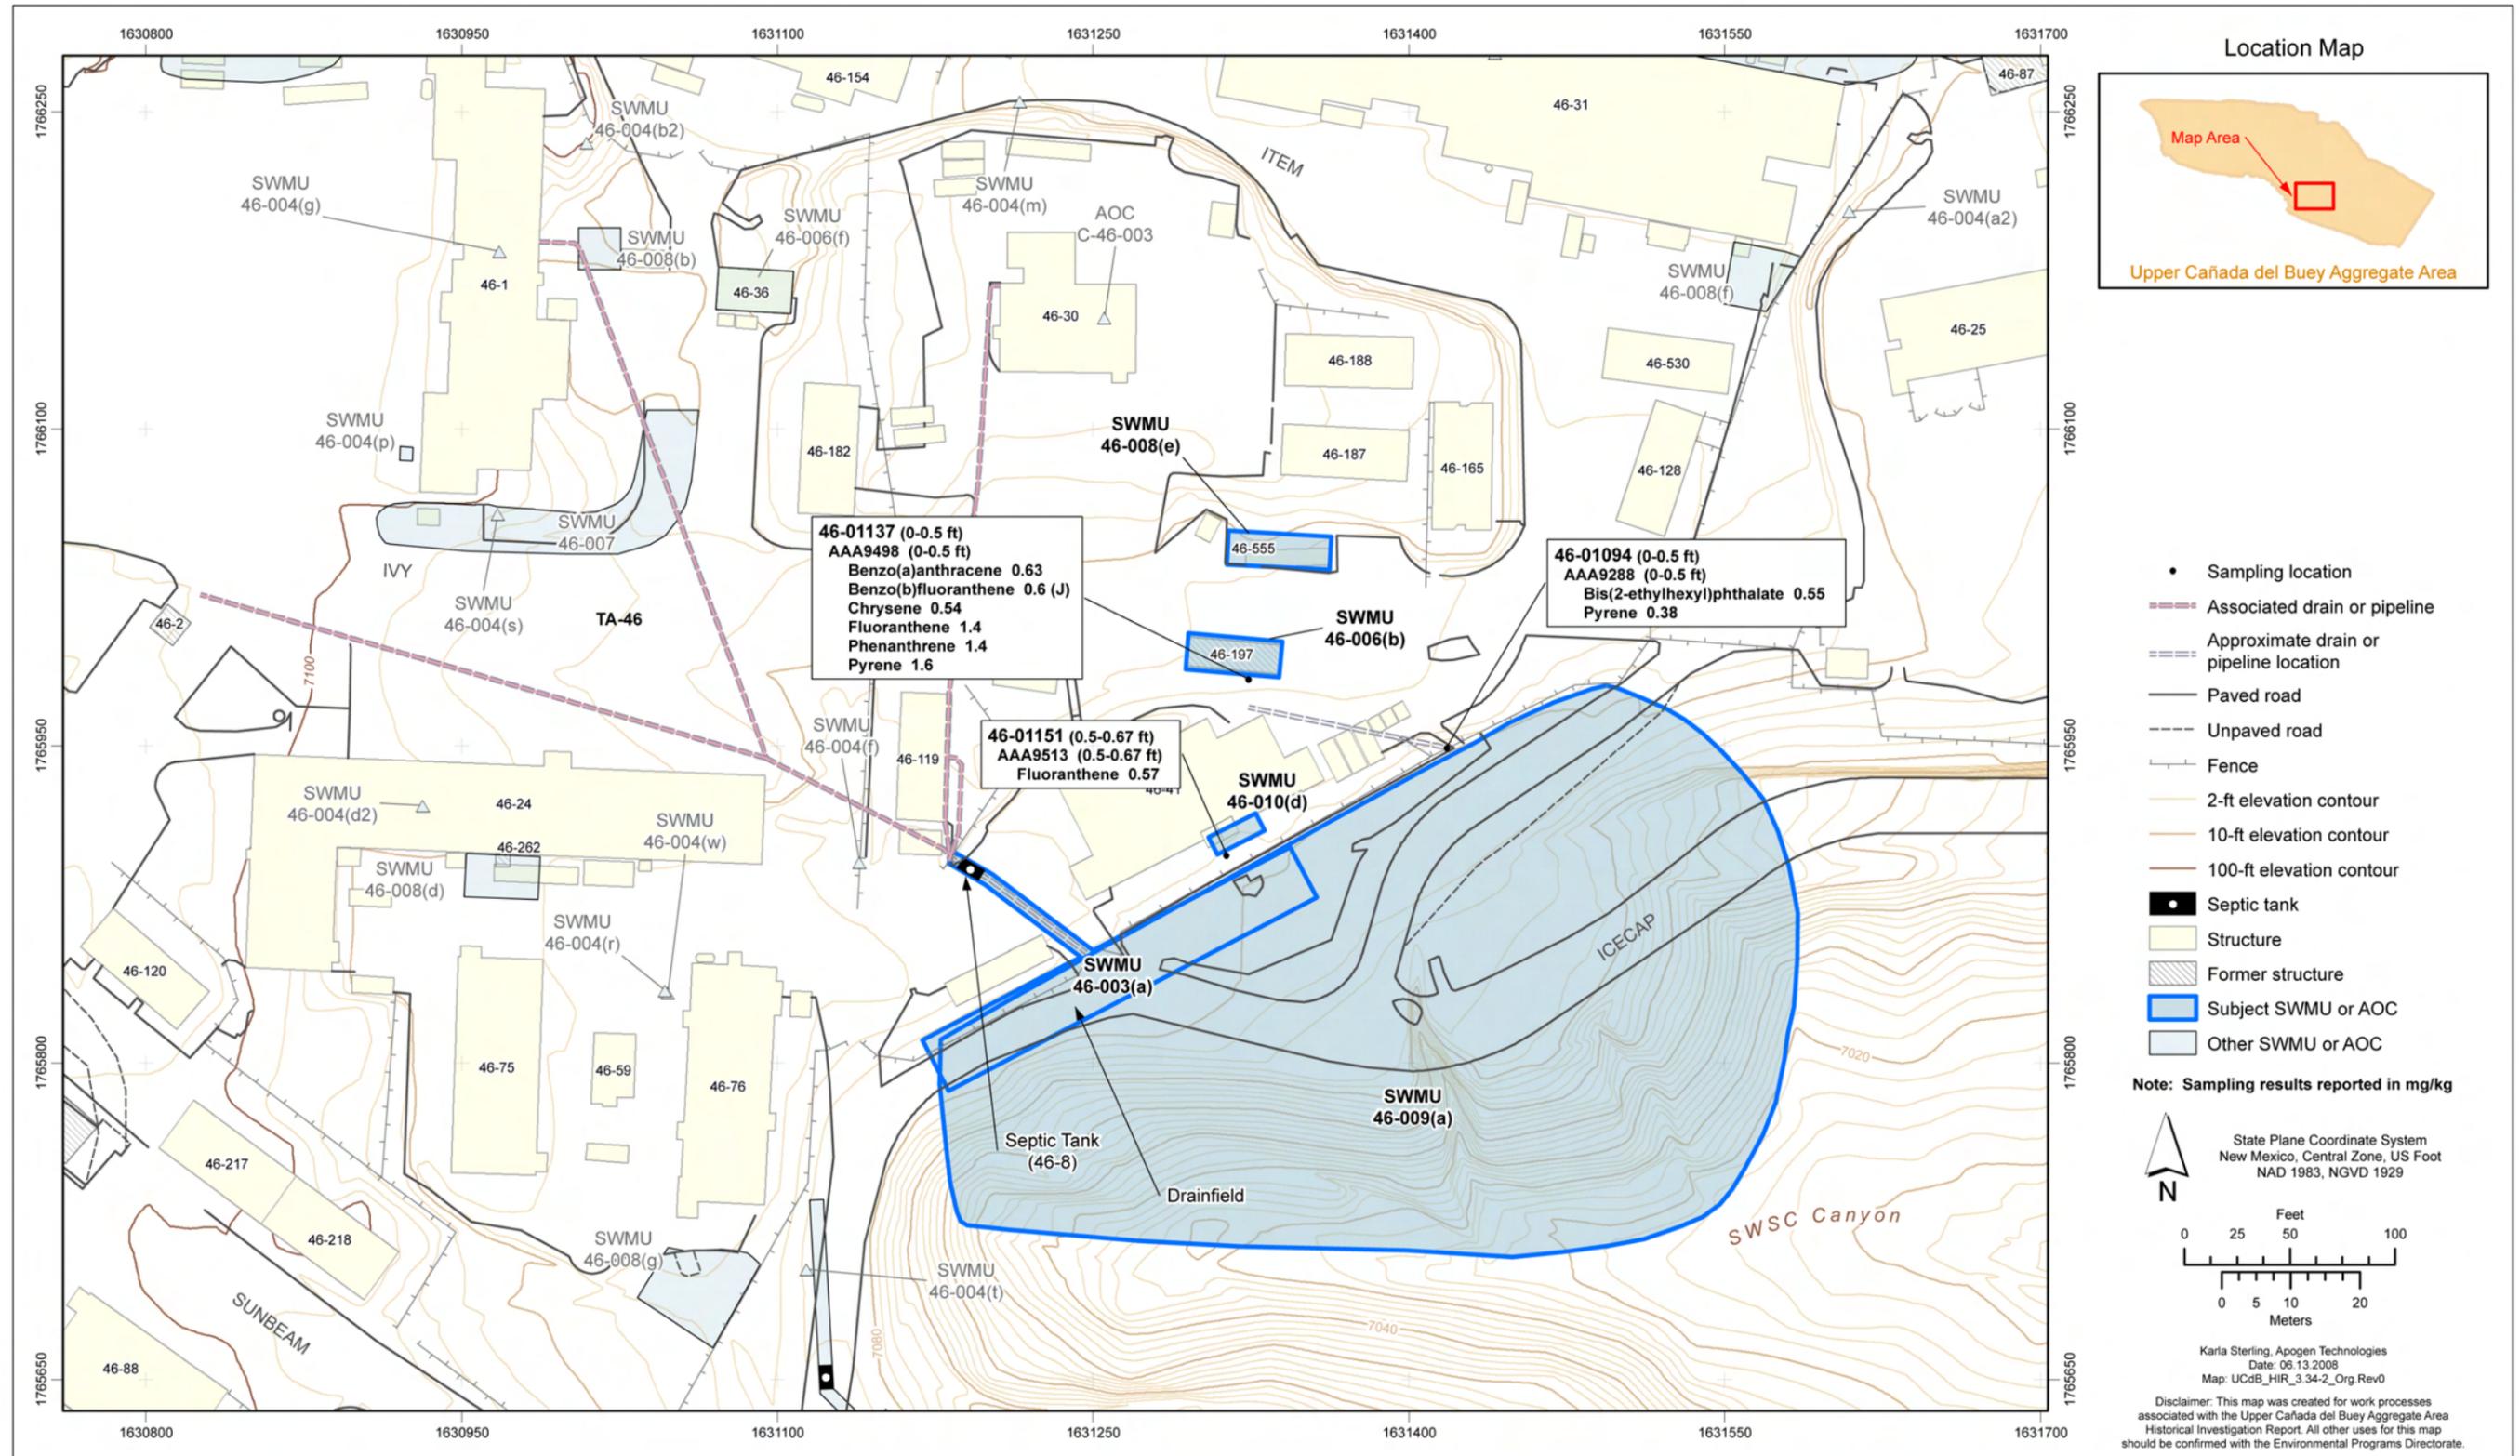
Figure 3.34-2 Organic chemicals detected at SWMUs 46-006(b) and 46-010(d)

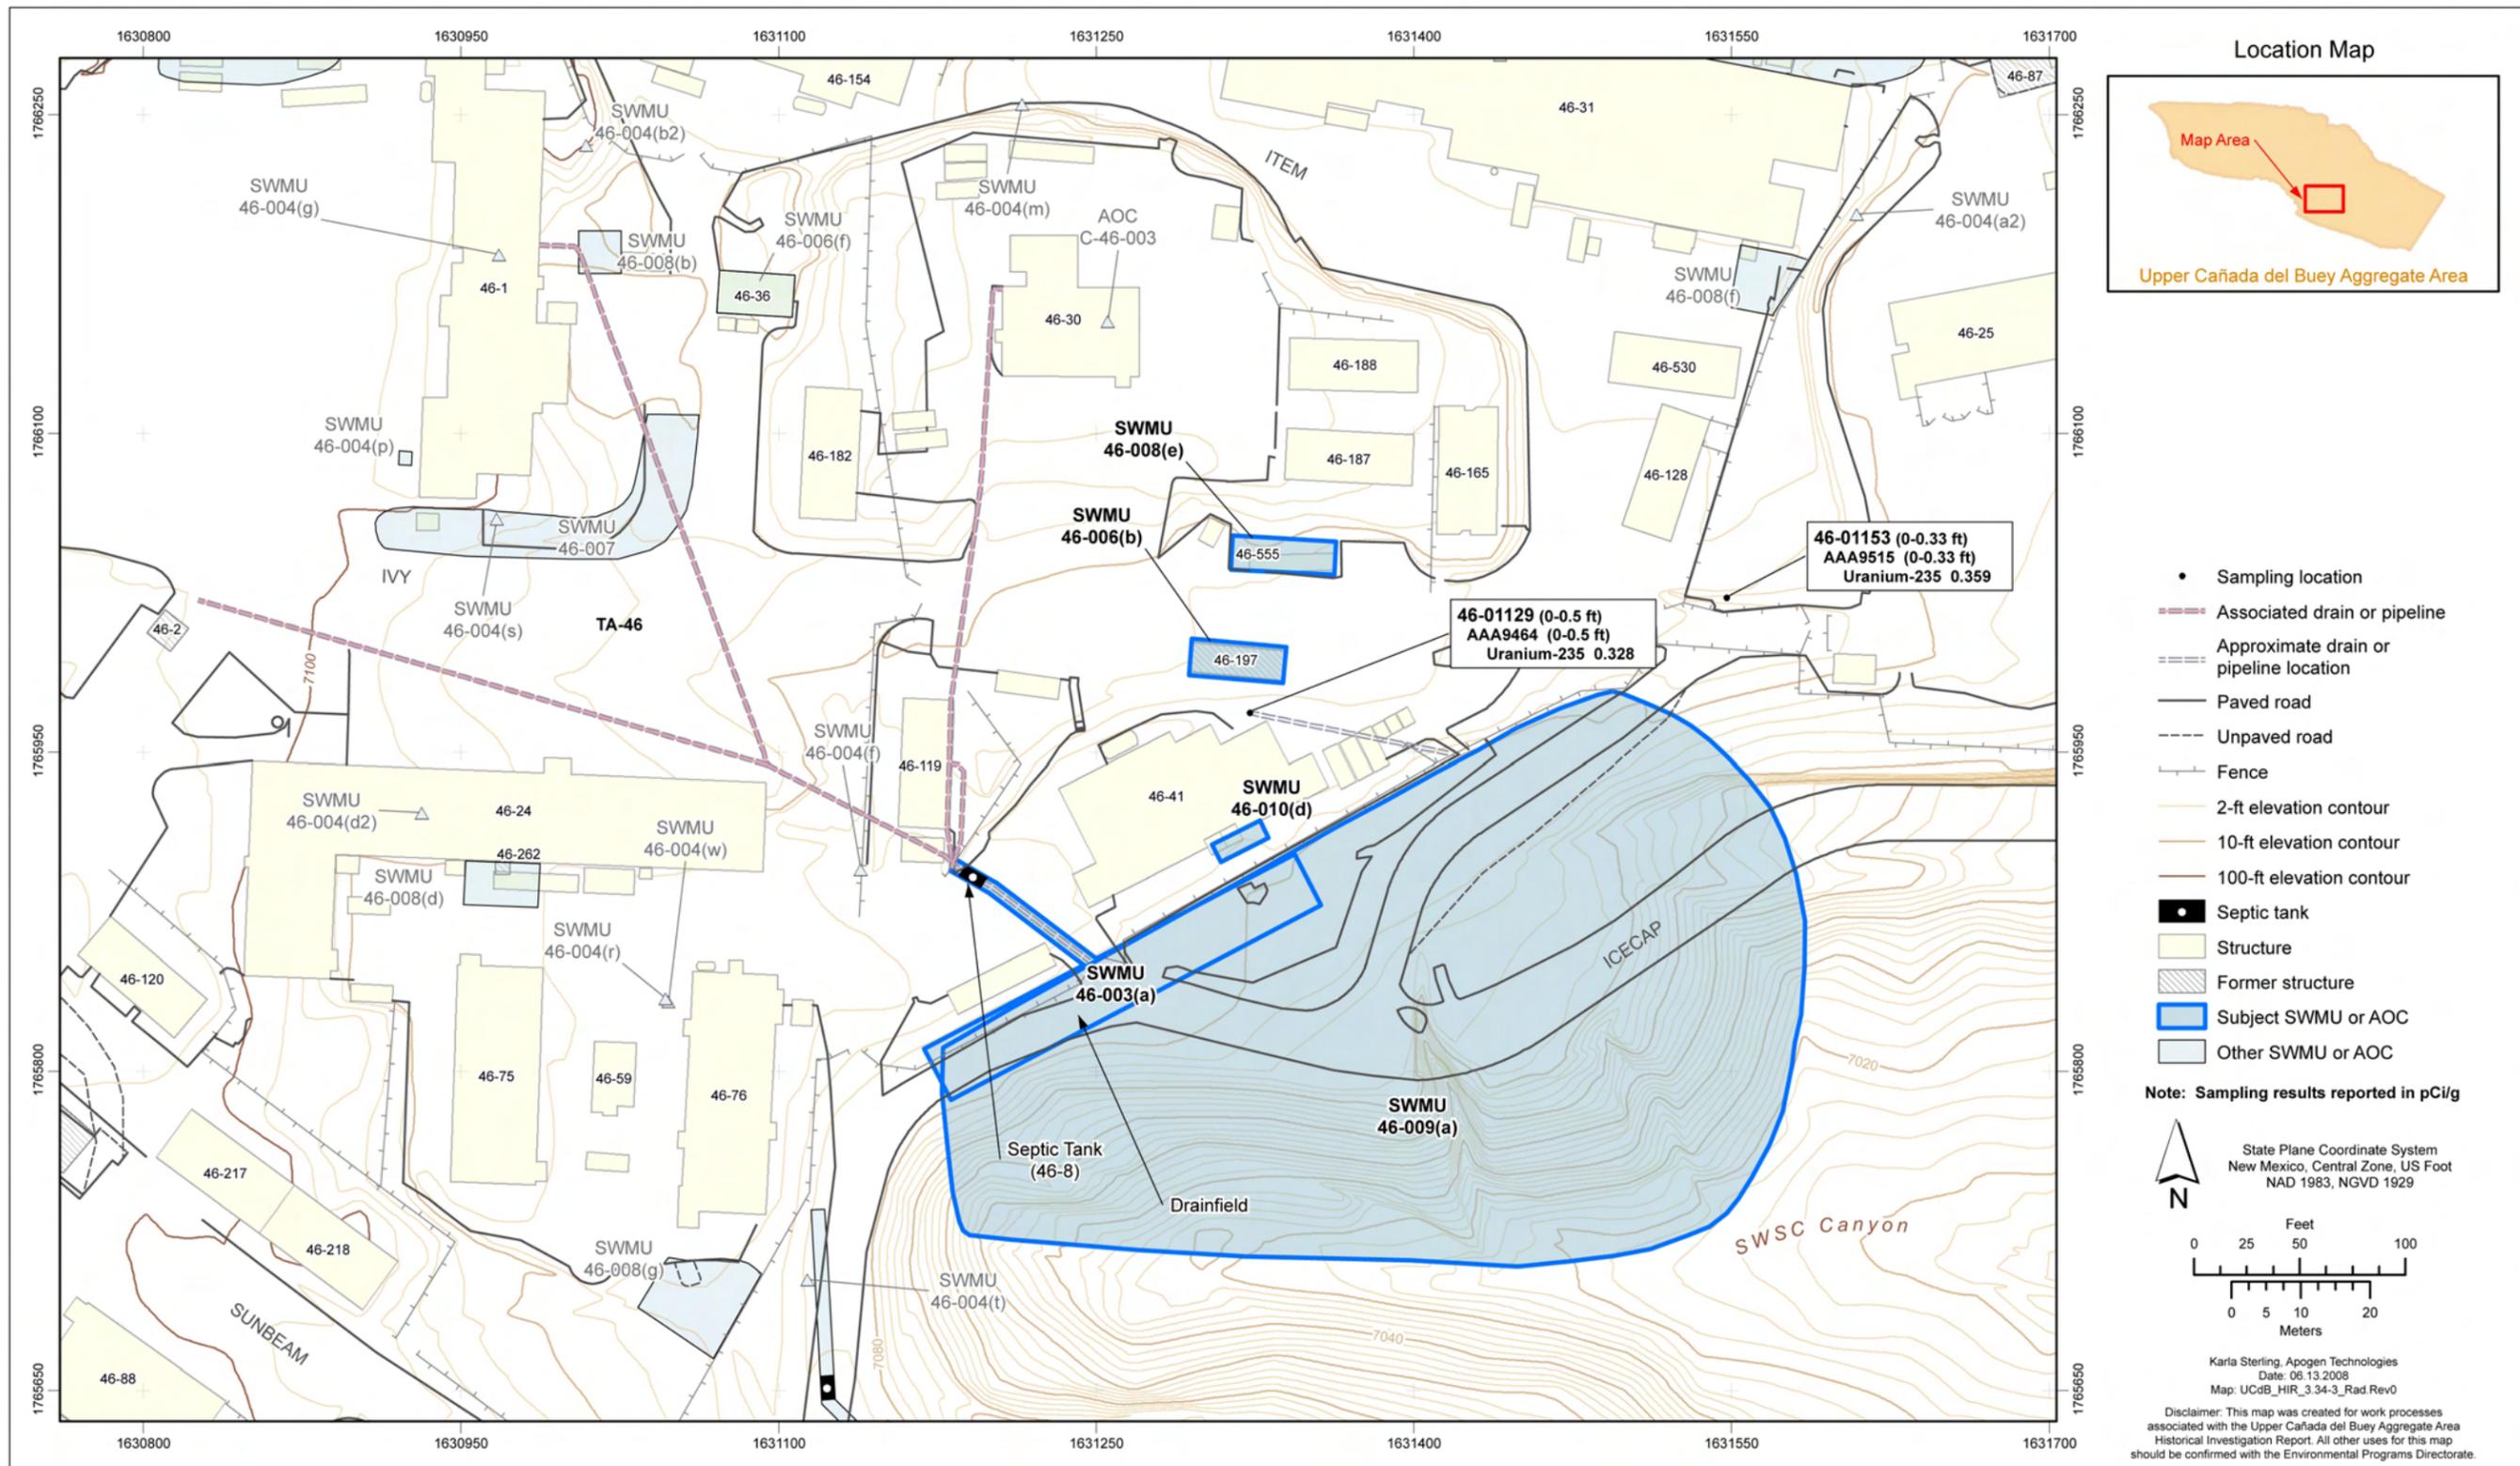
Figure 3.34-3 Radionuclides detected or detected above BVs/FVs at SWMUs 46-006(b) and 46-008(e)

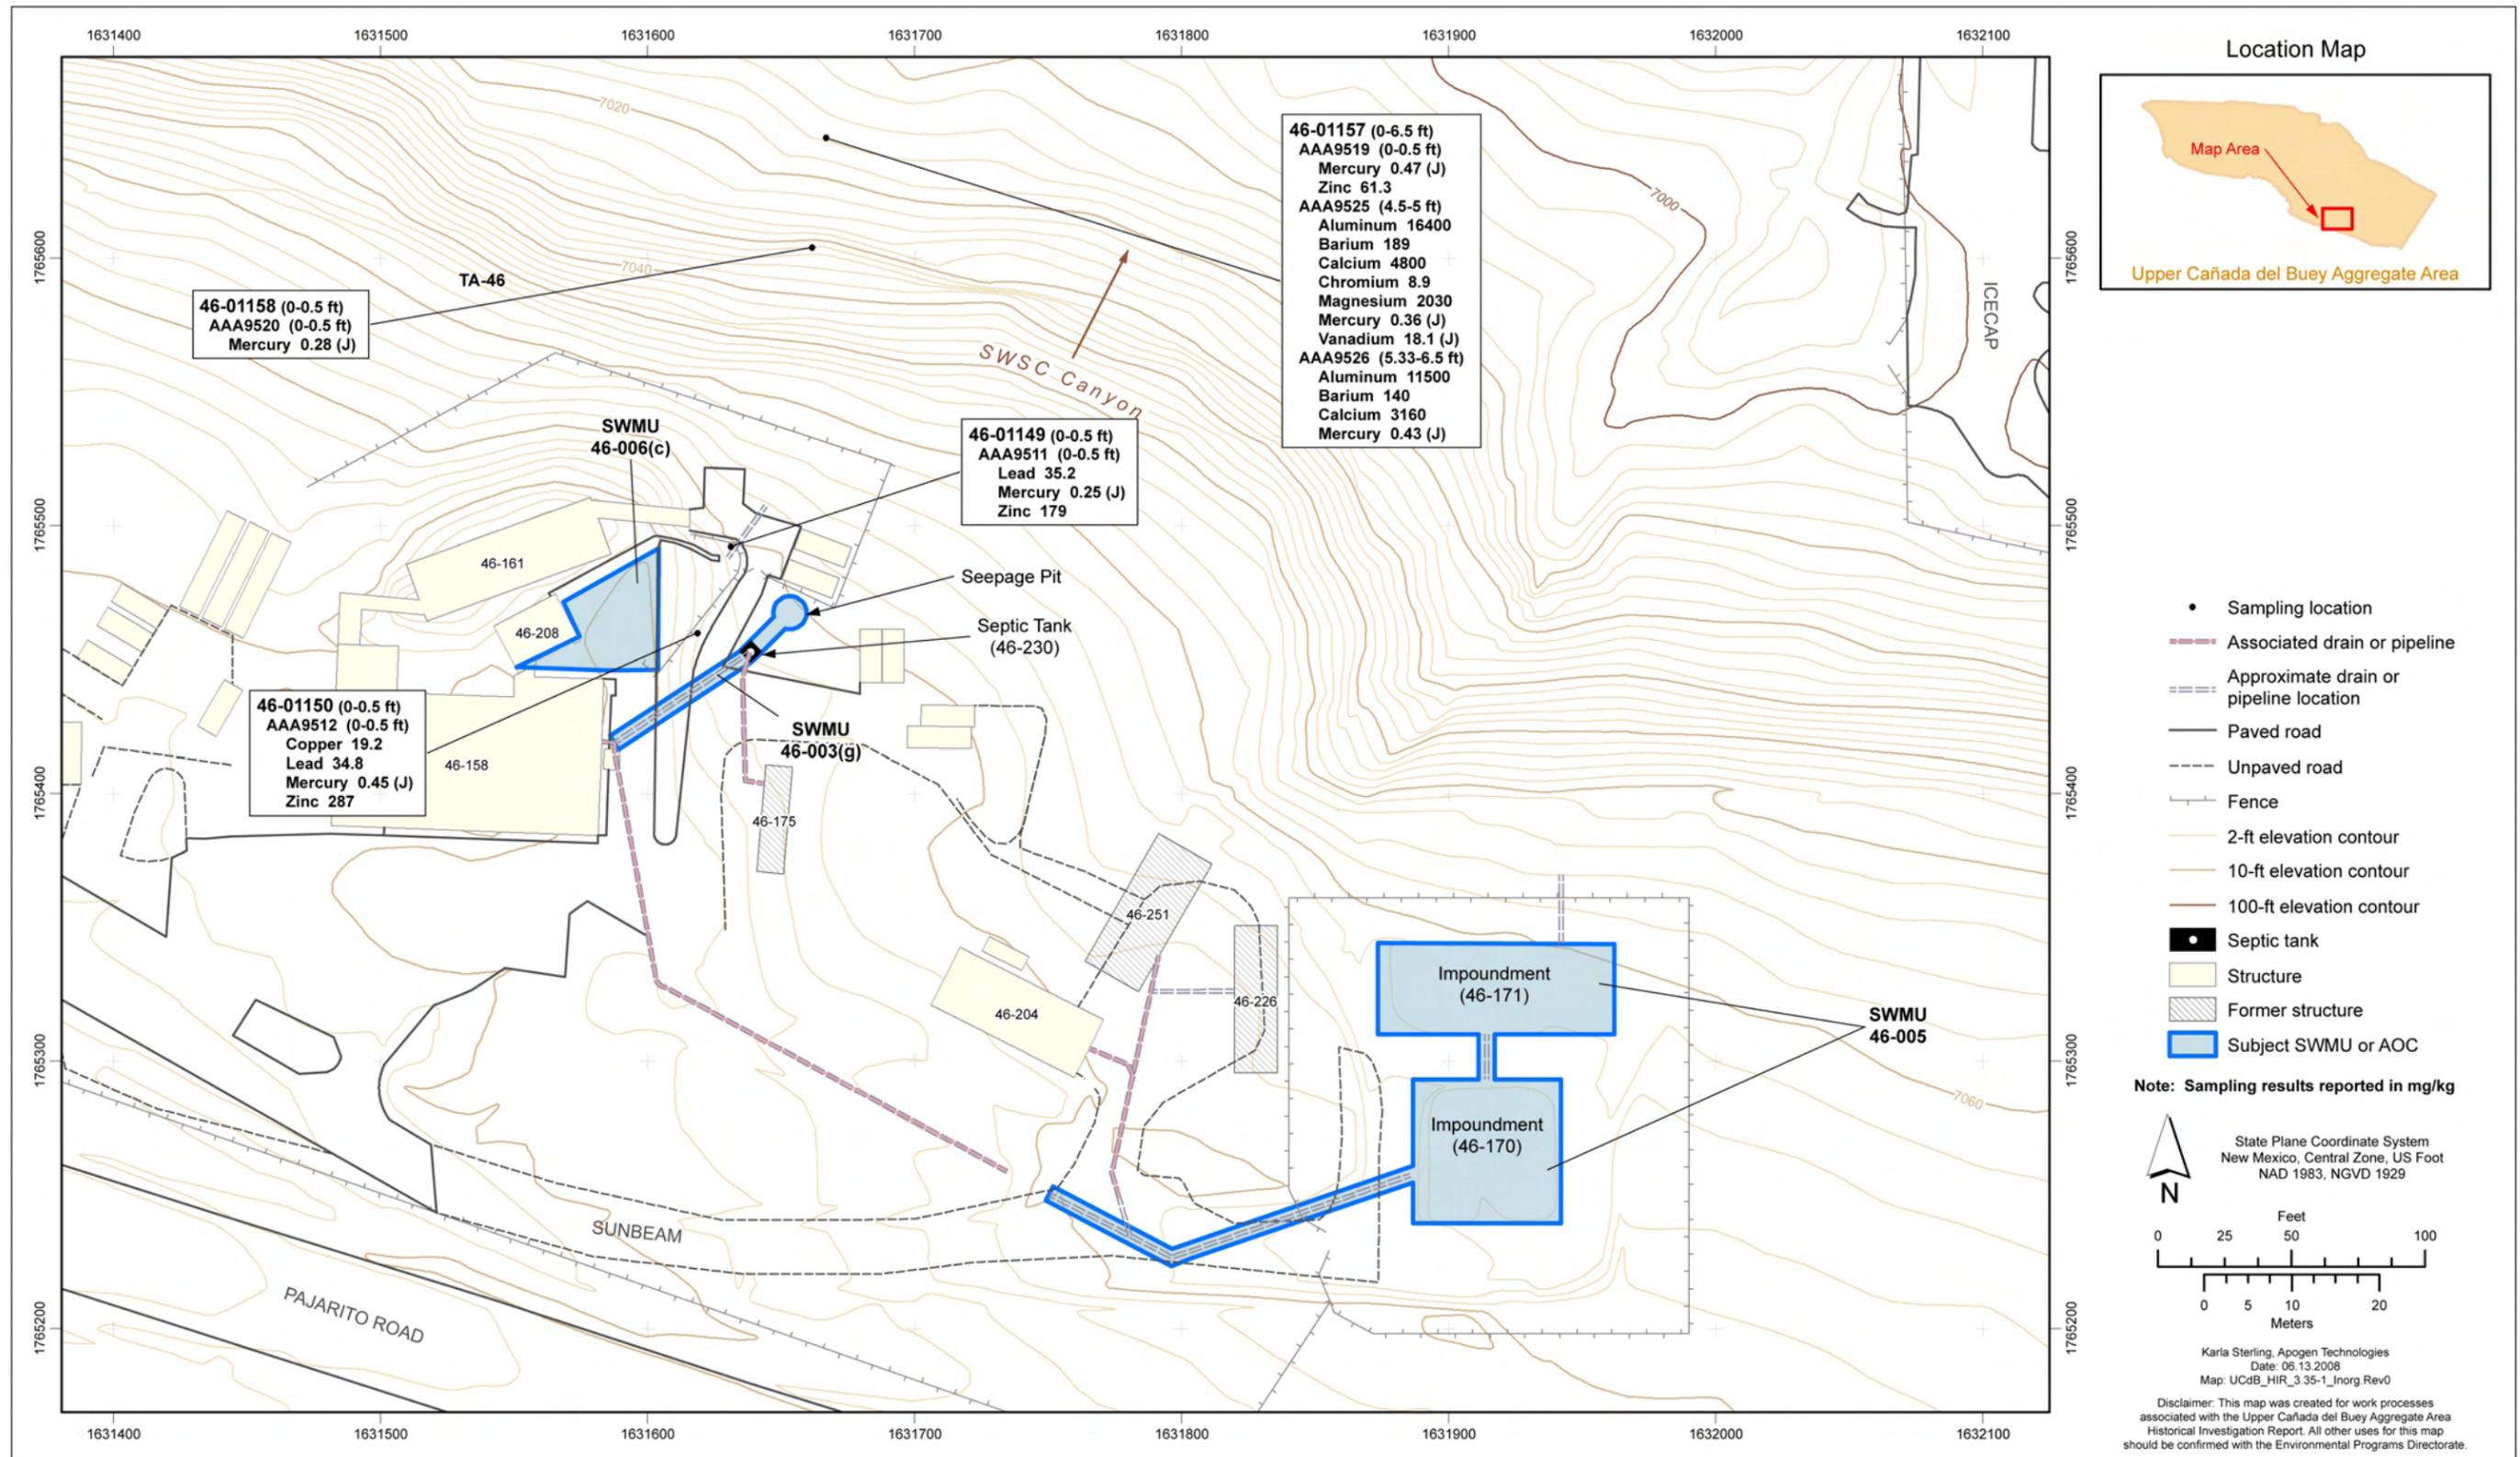
Figure 3.35-1 Inorganic chemicals detected above BVs at SWMU 46-006(c)

Analytical data are presented in Tables 3.35-2 and 3.35-3. The sampling locations and results for inorganic chemicals detected above BVs and organic chemical detected are shown in Figures 3.35-1 and 3.35-2, respectively. Chromium, magnesium, and vanadium were detected above BVs in one tuff sample; copper was detected above BV in one soil sample; aluminum, barium, and calcium were detected above BVs in two tuff samples; lead was detected above BV in two soil samples; zinc was detected above BVs in two soil and one sediment sample; mercury was detected above BV in all six samples. Detection limits for selenium and thallium were above BVs in four samples. Bis(2-ethylhexyl)phthalate was detected in the two soil samples. PCBs were not detected. Radionuclides were not detected or were not detected above BVs/FVs. PCBs were not detected.
