**Subject: Submittal of the Investigation Work Plan and the Historical Investigation Report for Upper Cañada del Buey Aggregate Area**

LA-UR-08-3864  
June 2008  
EP2008-0287

# Investigation Work Plan for Upper Cañada del Buey Aggregate Area

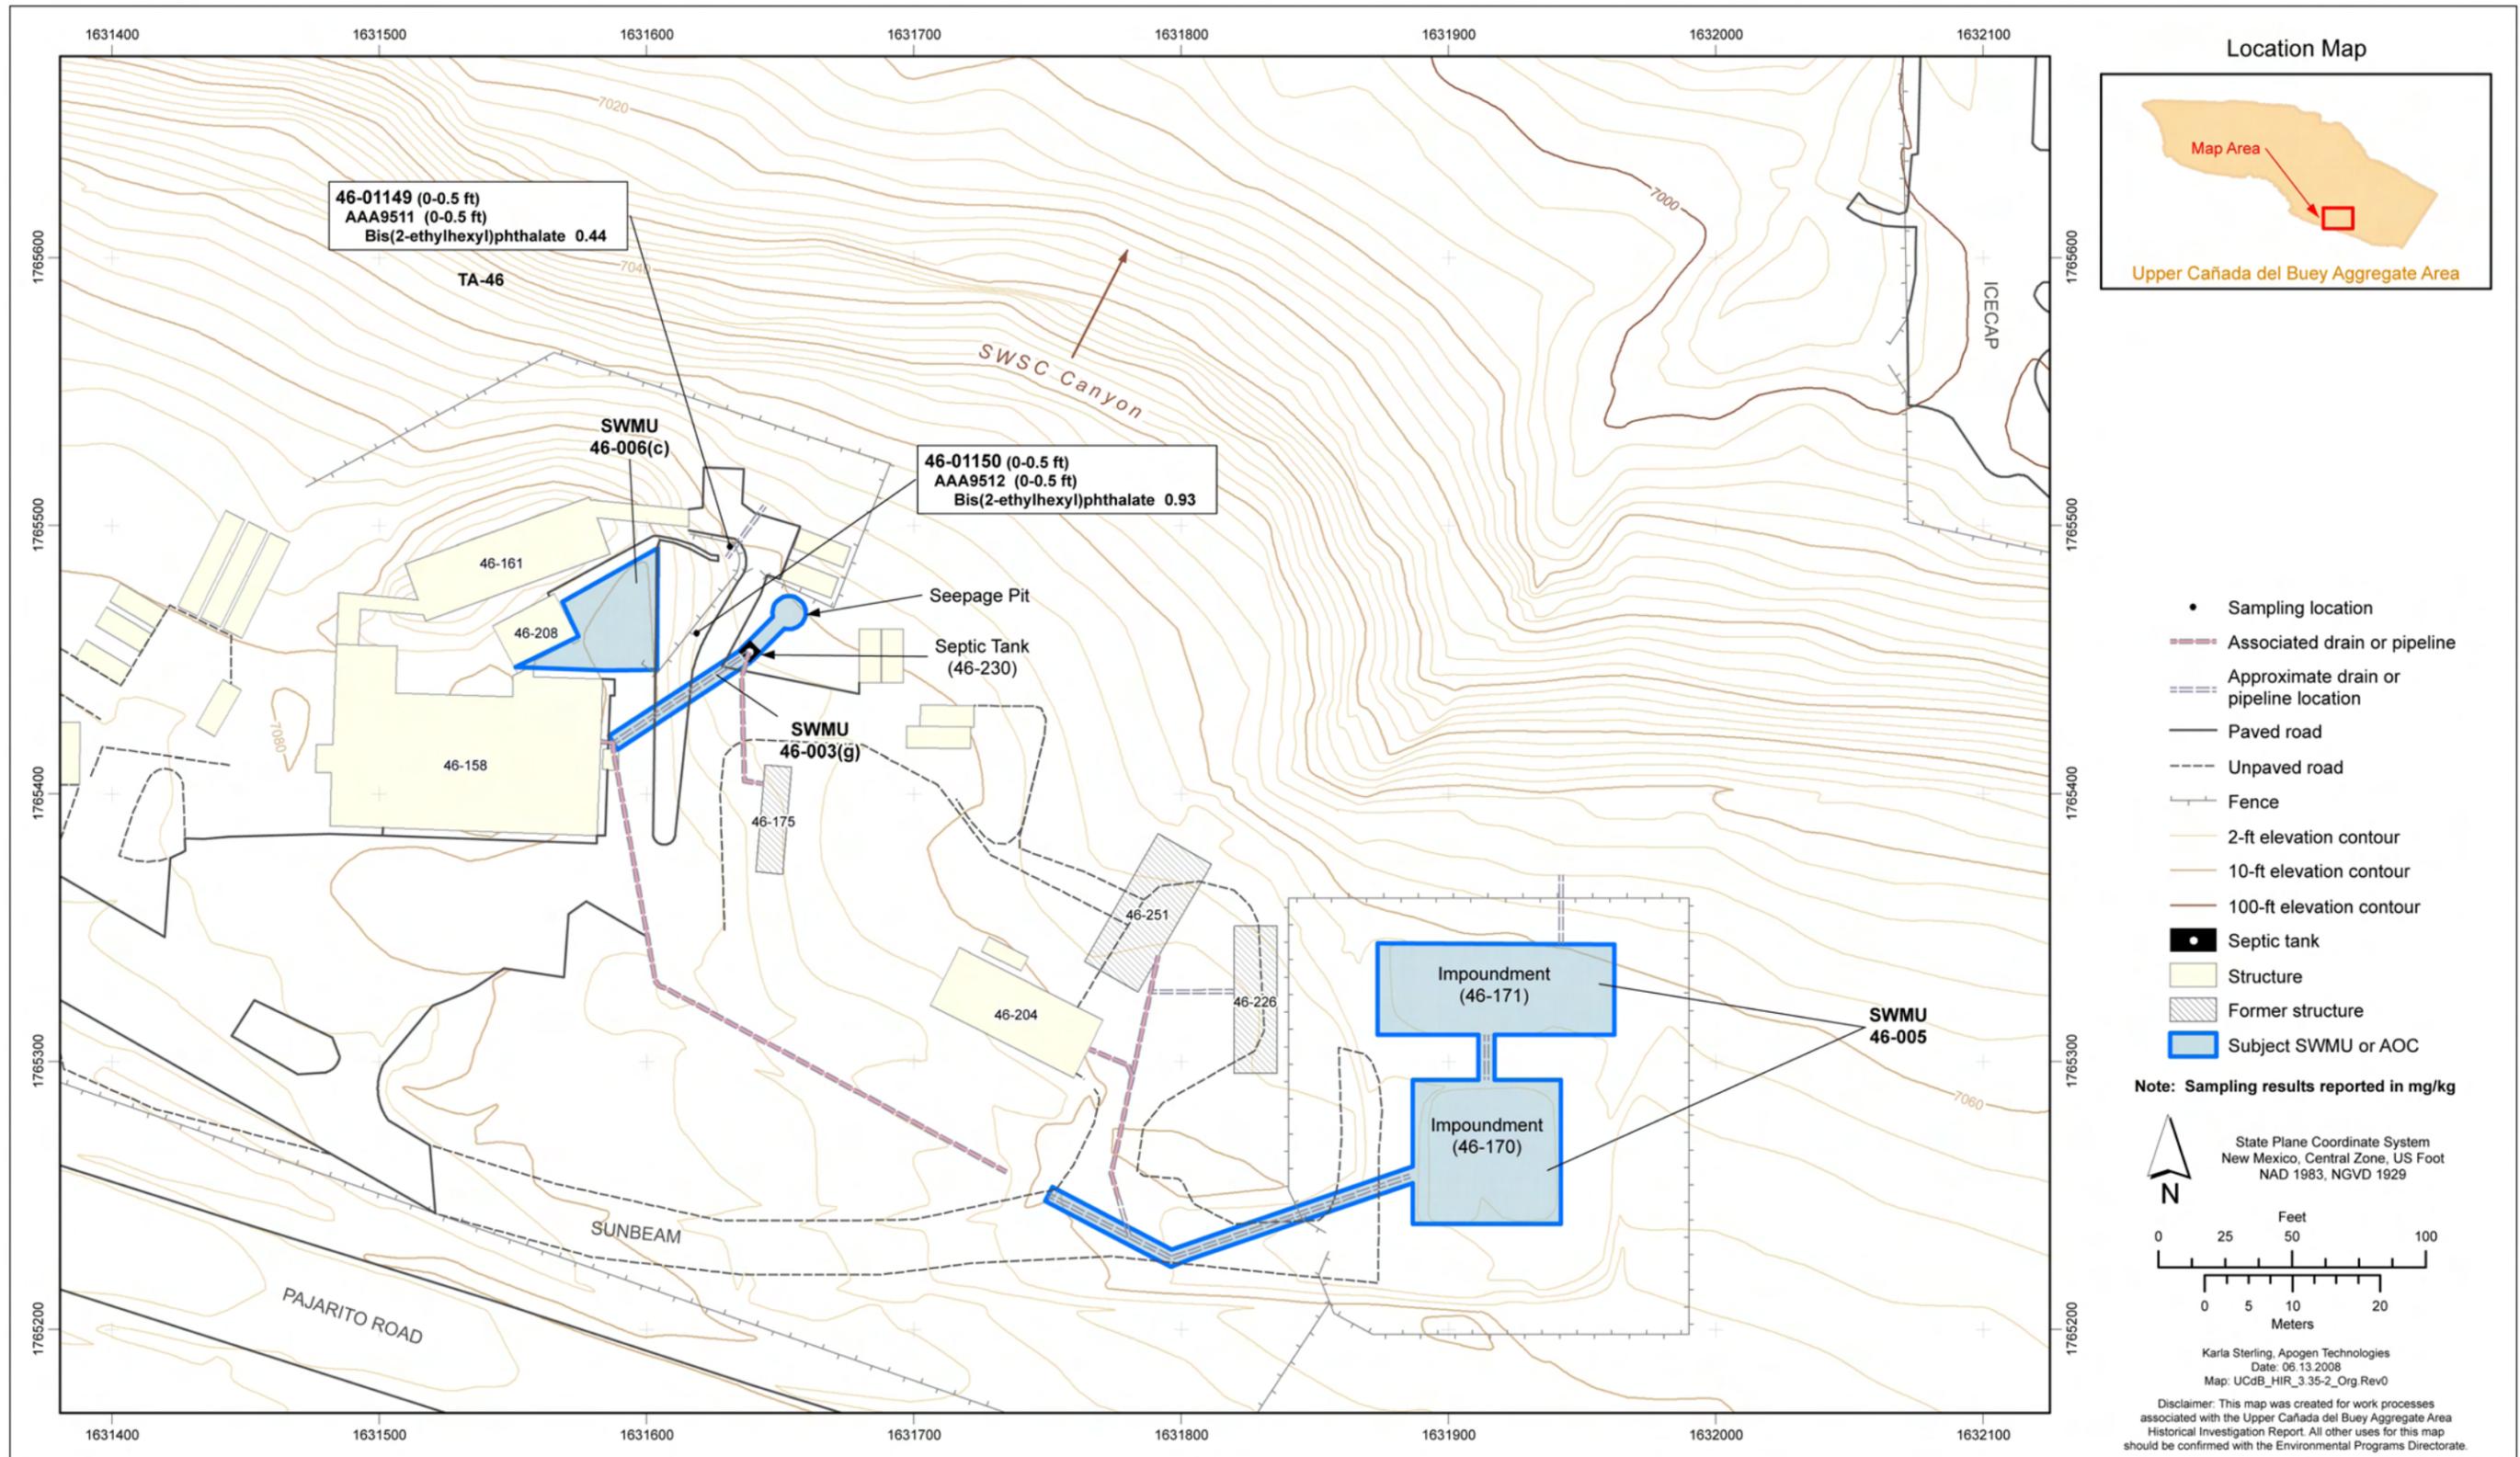
Figure 3.35-2 Organic chemicals detected at SWMU 46-006(c)

Analytical data are presented in Tables 3.35-2 and 3.35-3. The sampling locations and results for inorganic chemicals detected above BVs and organic chemical detected are shown in Figures 3.35-1 and 3.35-2, respectively. Chromium, magnesium, and vanadium were detected above BVs in one tuff sample; copper was detected above BV in one soil sample; aluminum, barium, and calcium were detected above BVs in two tuff samples; lead was detected above BV in two soil samples; zinc was detected above BVs in two soil and one sediment sample; mercury was detected above BV in all six samples. Detection limits for selenium and thallium were above BVs in four samples. Bis(2-ethylhexyl)phthalate was detected in the two soil samples. PCBs were not detected. Radionuclides were not detected or were not detected above BVs/FVs. PCBs were not detected.

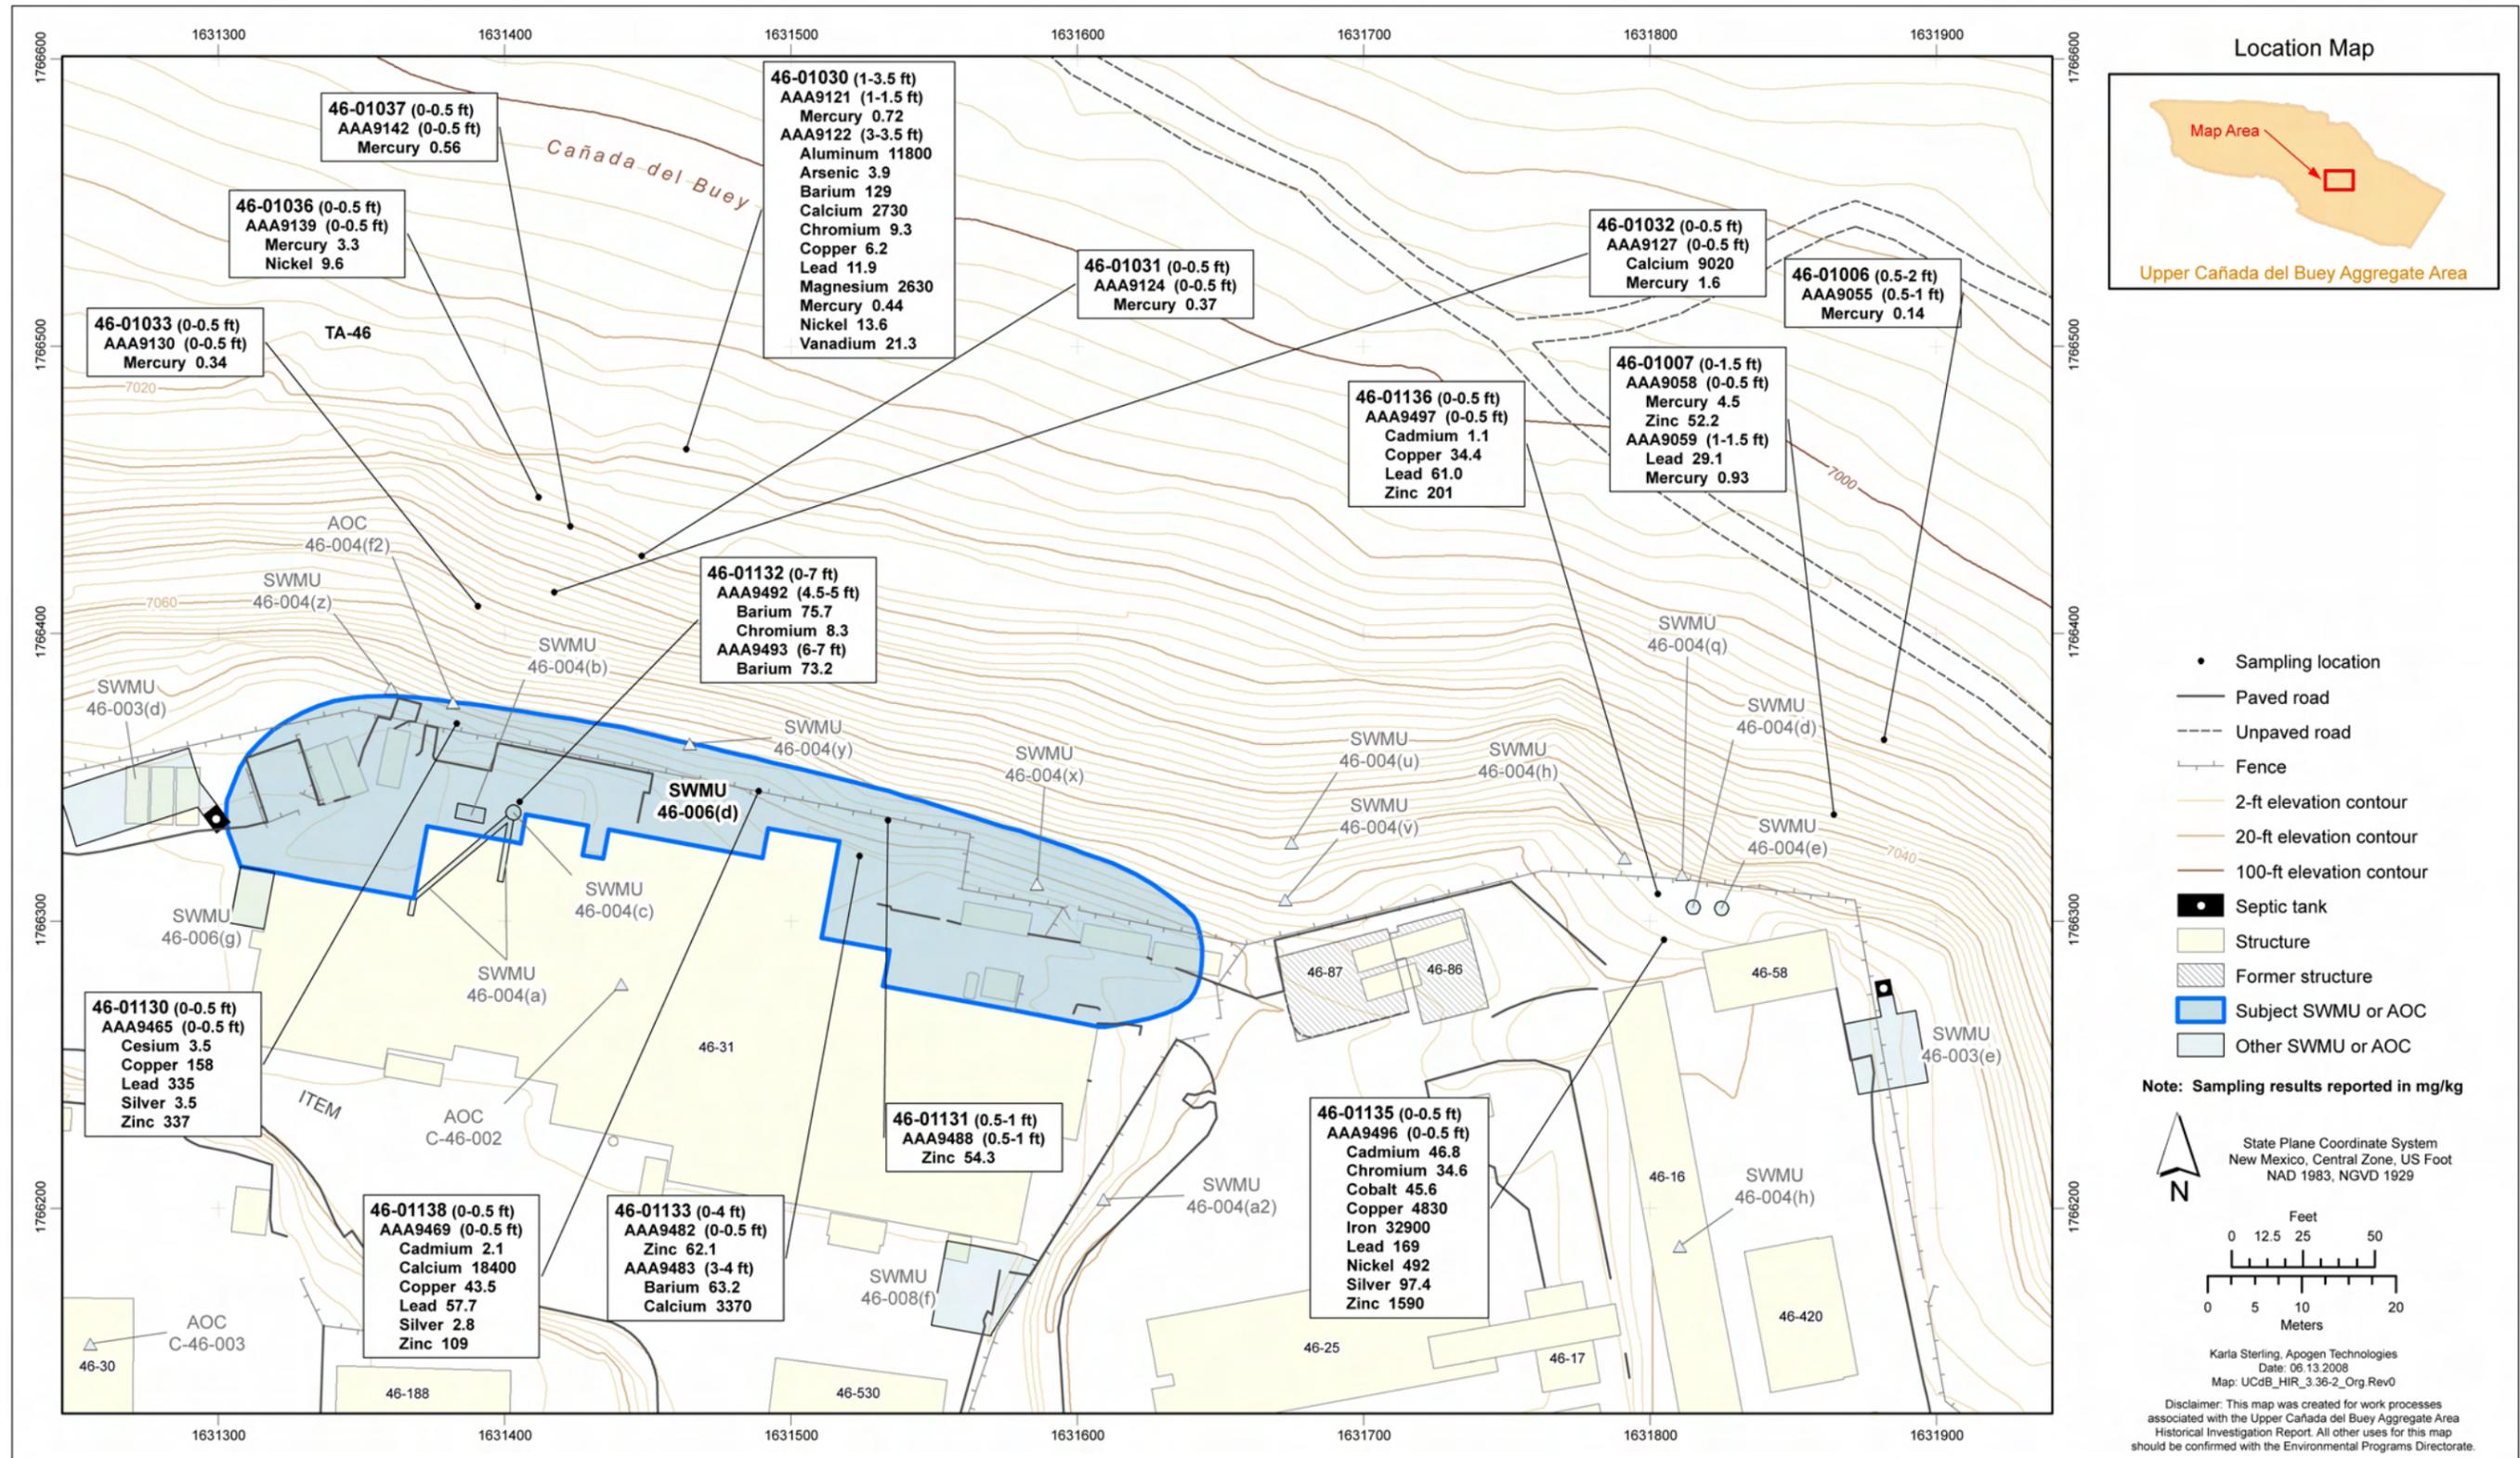
Figure 3.36-2 Inorganic chemicals detected above BVs at SWMU 46-006(d)

Analytical data are presented in Tables 3.36-2, 3.36-3, and 3.36-4. The sampling locations and results for inorganic chemicals detected above BVs, organic chemicals detected, and radionuclides detected or detected above BVs/FVs are shown in Figures 3.36-2, 3.36-3, 3.36-4, respectively. Aluminum, arsenic, magnesium, and vanadium were detected above BVs in one tuff sample; cobalt and iron were detected above BVs in one soil sample; cadmium and silver were detected above BVs in three soil samples; chromium was detected above BVs in two tuff samples and one soil sample; nickel was detected above BVs in one soil, one sediment, and one tuff sample. Barium was detected above BV in four tuff samples; calcium was detected above BVs in one soil, one sediment, and two tuff samples. Copper was detected above BVs in one tuff and four soil samples; lead was detected above BVs in four soil and two tuff samples. Mercury was detected above BVs in three soil, five sediment, and two tuff samples; zinc was detected above BV in seven soil samples. Detection limits for antimony, cadmium, cobalt, selenium, silver, and thallium were above BVs in 1 to 11 samples. Acenaphthene and bis(2-ethylhexyl)phthalate were detected in one soil samples; methoxychlor(4,4'-) was detected in one tuff sample. Dieldrin was detected in two soil samples; TCA and TCE were detected in two tuff samples. Aroclor-1254 was detected in three soil samples. Cesium-137 was detected in two soil samples. Plutonium-238 was detected above FV in one fill and four soil samples and above BV in three sediment samples. Plutonium-238 was also detected in one soil sample at depths greater than the applicable FV and was detected in two tuff samples. Uranium-234 was detected above BV in one soil sample. Isotopic thorium was not detected or was not detected above BVs.
